# Natural Resource Protection Act (NRPA) Identification Guide for Rivers, Streams, and Brooks

Babel Brook, Ebeemee TWP

MAINE DEPARTMENT OF ENVIRONMENTAL PROTECTION  
17 State House Station | Augusta, Maine 04333-0017  
<http://www.maine.gov/dep/>

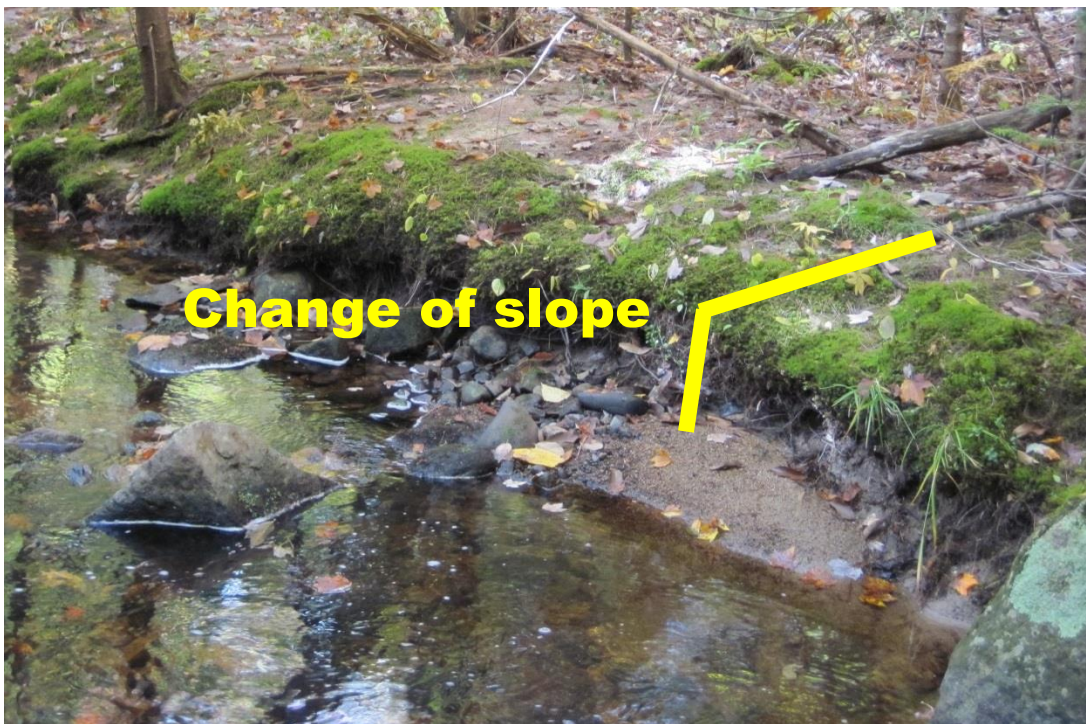
Figure 2. Stream channel showing a distinct change of slope where the stream bank transitions to the floodplain

Stream channels come in many shapes and sizes depending on their location in the landscape. The transition from a stream bank to an adjacent upland is often clearly evident (Figure 2). Often, there is a change of slope where the more vertical stream bank meets the more horizontal upland. The change in slope is normally accompanied by a change of substrate material, topsoil, vegetation, and leaf litter. One exception is when large rock is part of the stream bank. In that case, instead of a change of slope, the water level varies up and down the rock. In these cases, water staining and lack of moss or lichens may be evident on the side of the rock where it is periodically submerged. In contrast, some streams in flat landscapes have less clearly defined stream banks (Figure 3). The transitions between stream channels and neighboring wetlands or floodplains may be less distinct. There still may be a change of substrate and/or vegetation, however. Some streams flowing through wetlands may only be apparent during low flow or if one wades into the wetland.

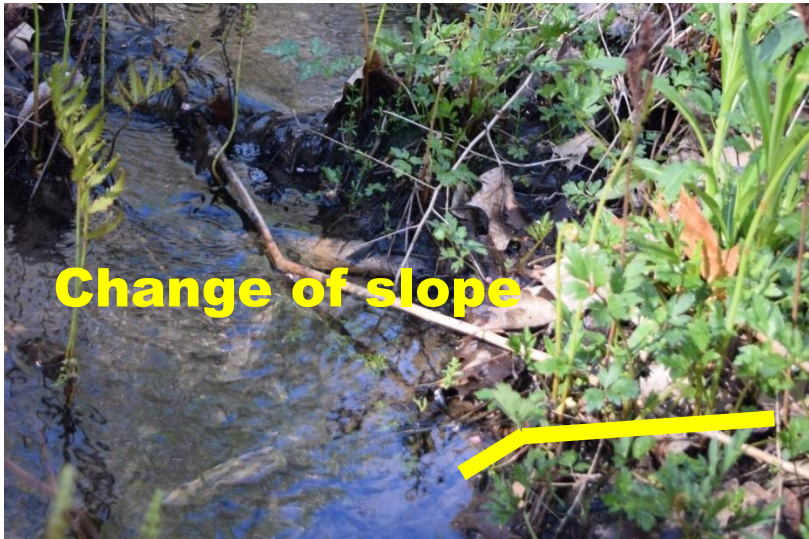
Figure 3. Small stream channel showing a less distinct change of slope where the stream bank transitions to the wetland

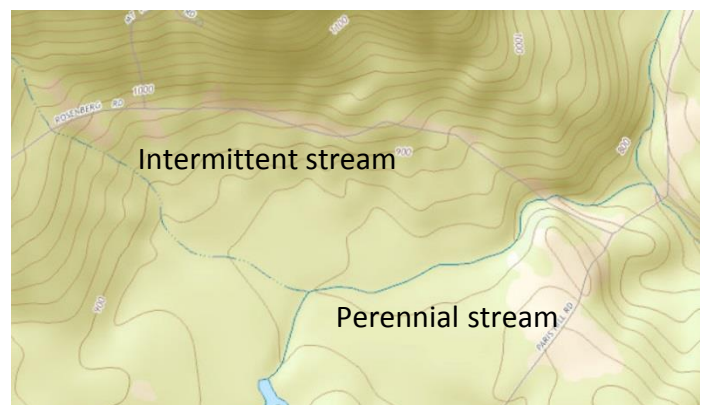
Figure 4. Solid and broken lines on 7.5-minute USGS topographic map representing perennial and intermittent streams, respectively

broken line (Figure 4). Solid lines represent perennial streams. Broken lines represent intermittent streams that may dry up. It is worth noting that many headwater streams do not appear on topographic maps, but the location of their channels may appear as U-shapes in elevation contours, which point uphill (Figure 4 – Intermittent Channel). Rarely, some channels that are mapped as streams do not meet two or more other criteria and therefore are not considered streams or brooks under the NRPA.

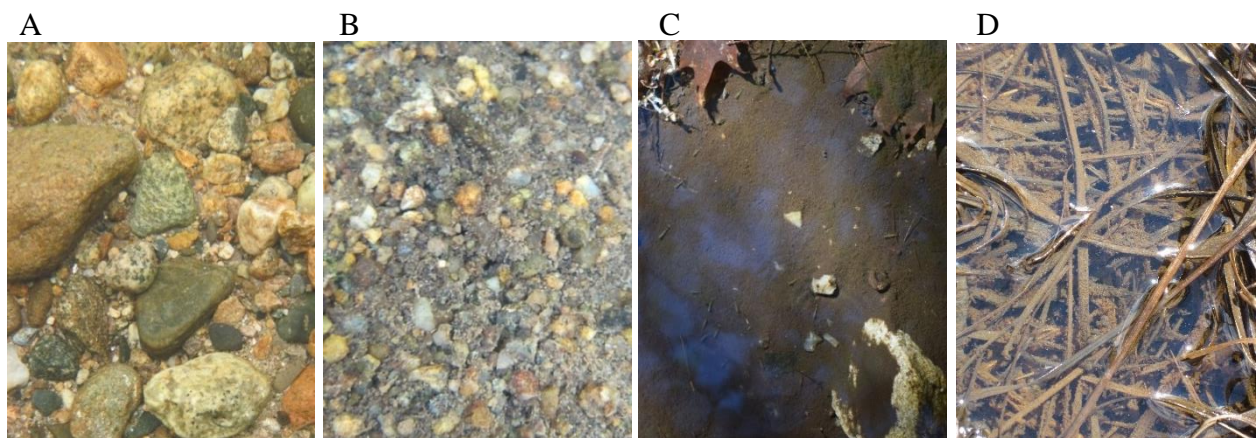
Figure 5. Examples of mineral substrate including (A) cobble and gravel, (B) coarse sand, and (C) mud, composed of sand and silt with some organic matter. Example of an organic substrate composed of a thick layer of decomposing plants (D).

To meet this criterion, a stream must have a channel bed primarily composed of mineral material. The mineral material may be scoured and exposed by flowing water. In other cases, flowing water may deposit mineral material that was carried from upstream. Mineral materials range in size from bedrock to boulder, cobble, sand, silt, and clay (Figure 5). Substrates primarily composed of thick layers of leaves, decaying plant parts, or peat moss would not qualify as mineral material for NRPA purposes.

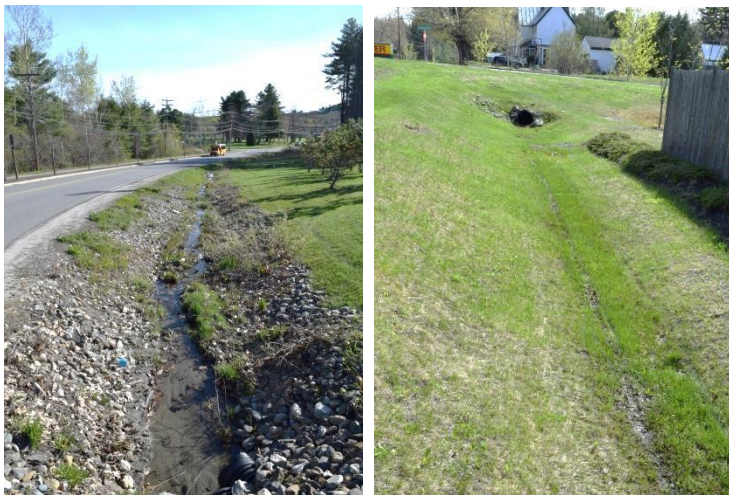
Figure 5. Examples of a drainage ditch and a grassy swale

In contrast, some drainage ways that may look like ditches are NRPA streams if they convey more than stormwater. To determine if a ditch/swale/drainage way is part of a NRPA stream, one needs to walk upstream and find the source of the water. A drainage way would be considered an altered stream segment if it connects to an upstream waterbody, such as a stream, spring, wetland, or pond. Stream segments that have been altered or relocated by human activities remain NRPA streams or brooks (e.g., case studies 10 and 11), therefore stream segments that have been diverted into roadside drainage features are still NRPA streams (e.g., case studies 14 and 15). Also, some drainage ways originating from culverts are NRPA streams if they are altered streams or brooks. This sometimes occurs where the headwaters of a stream were buried or piped (e.g., case study 17). In contrast, a drainage originating from a culvert would not be a NRPA stream if the only source of water is stormwater (e.g., case study 18).

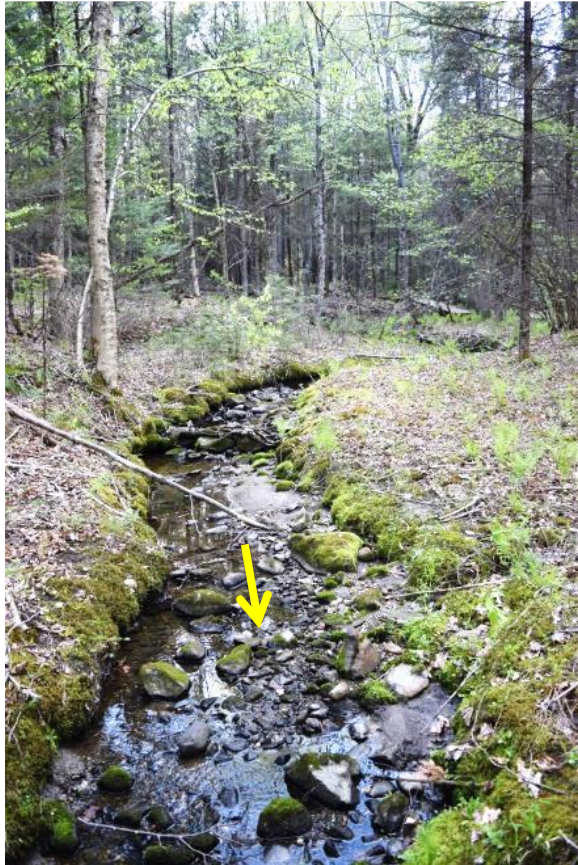
## Case Study 1 – Perennial stream

Criteria	Evidence	
Channel	✓	Clearly defined channel and banks (2-3 feet wide)
A. Mineral channel bed	✓	Composed of rocks and sand
B. Blue line on topographic map	✓	Solid line
C. Continuous flow for 6 months	✓	Only stops flowing during droughts
D. Aquatic life	✓	Many different kinds of aquatic macroinvertebrates and a two-lined salamander were observed
E. Aquatic vegetation	×	None
Conclusion	✓	It has a defined channel and meets 4 of the 5 other criteria. It is a NRPA stream.

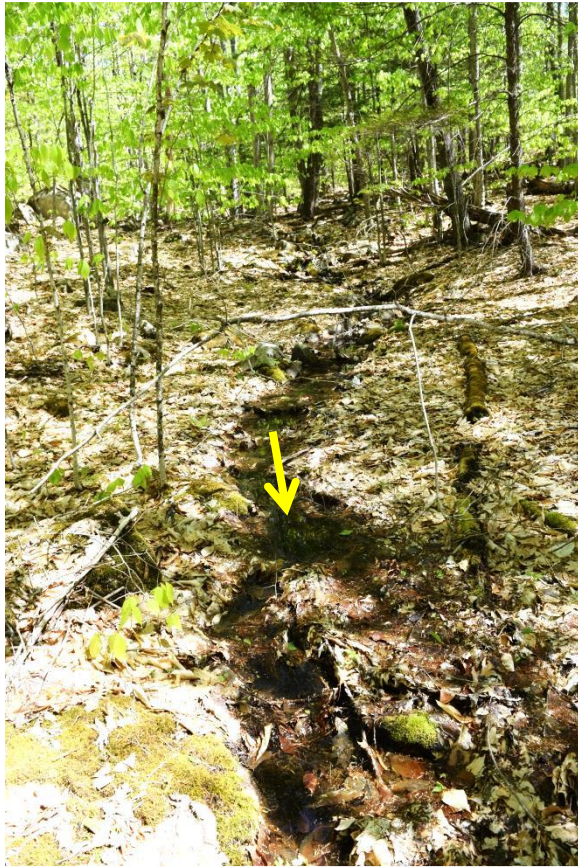
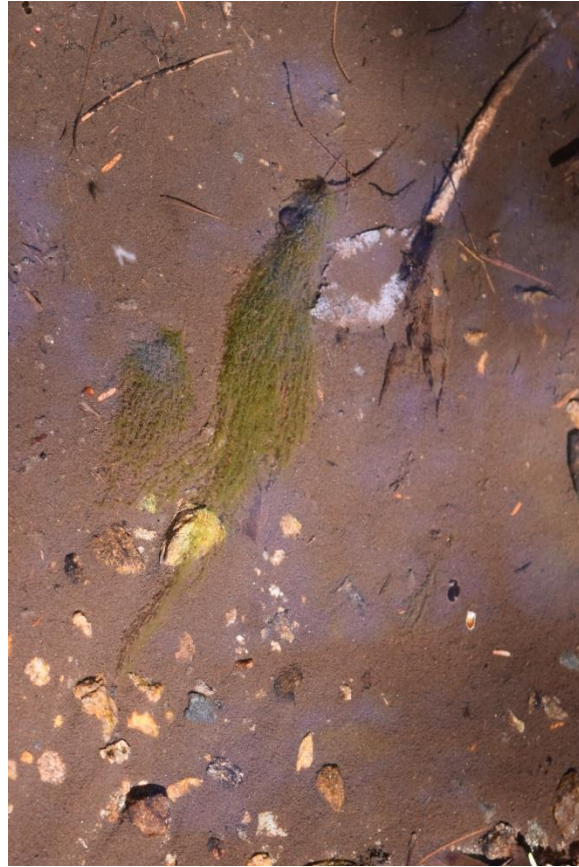
Criteria	Evidence	
Channel	✓	Narrow channel with defined banks (3-8" wide, <1" deep in most places) (A)
A. Mineral channel bed	✓	Composed of sand, silt, and rocks (B)
B. Blue line on topographic map	×	It is not shown as a blue line on the topographic map
C. Continuous flow for 6 months	--	Not evaluated
D. Aquatic life	✓	Several different kinds of aquatic macroinvertebrates and a two-lined salamander were observed
E. Aquatic vegetation	×	None
Conclusion	✓	It has a defined channel and meets 2 of the 5 other criteria. It is a NRPA stream.

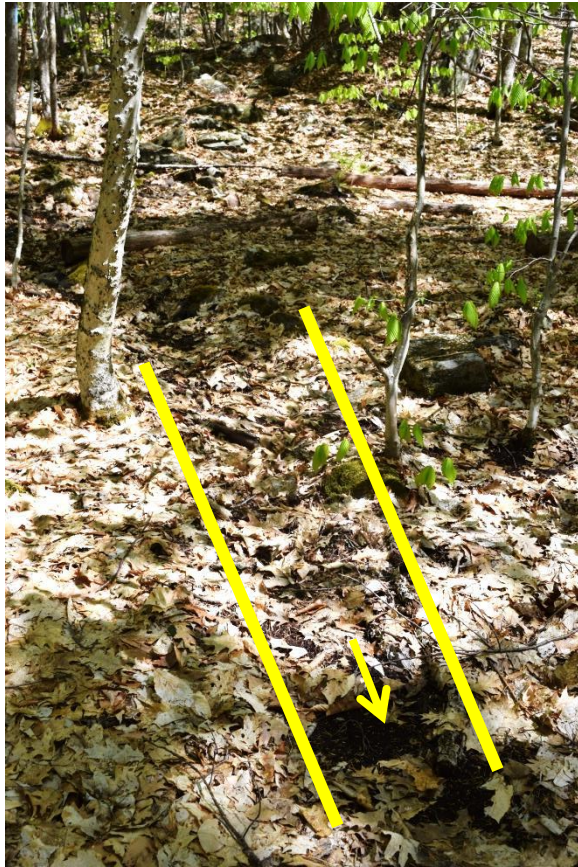
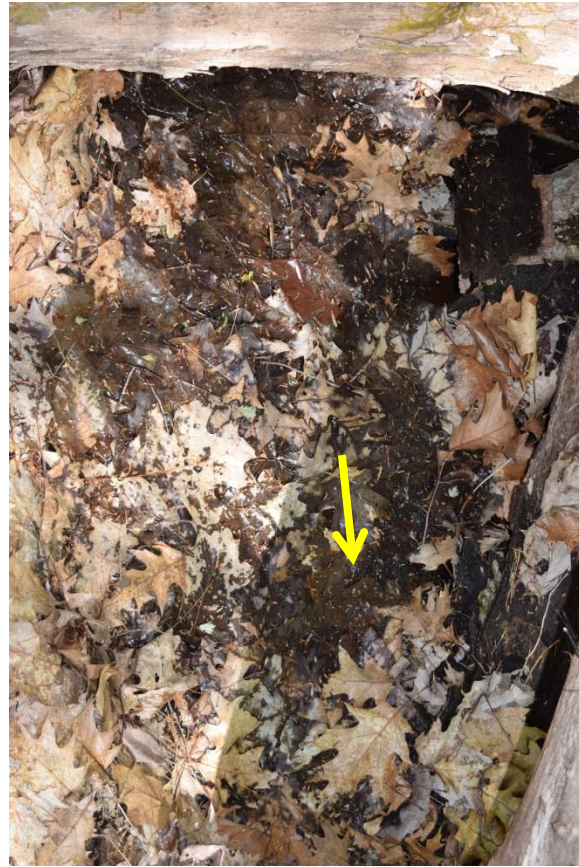
### Case Study 3 – Intermittent drainage #2

Criteria	Evidence
Channel	× Water flowing through leaves, but there is no defined channel (yellow lines added to show area with flowing water)
A. Mineral channel bed	× Water movement did not create a channel bed that is different from the surface layer of surrounding upland soils
B. Blue line on topographic map	× It is not shown as a blue line on the topographic map
C. Continuous flow for 6 months	× Dries up
D. Aquatic life	× None found in a 15-minute search
E. Aquatic vegetation	× None
Conclusion	✗ Without a defined channel, it is not a NRPA stream

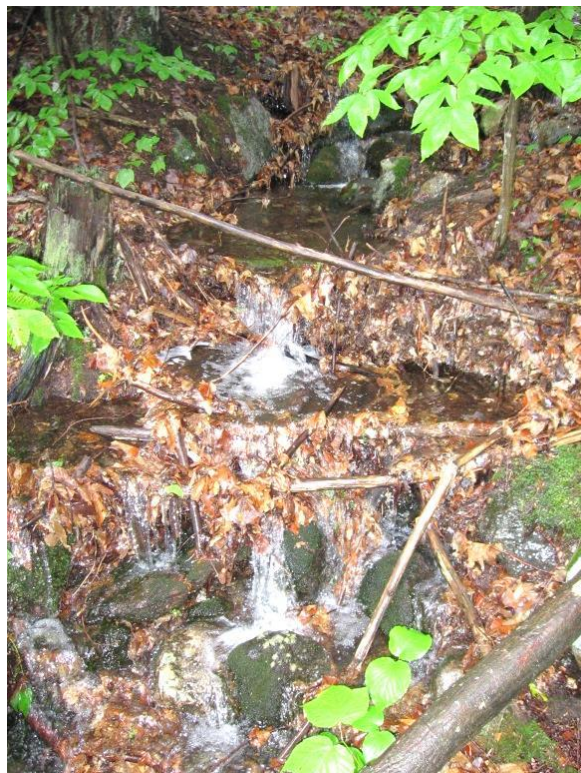
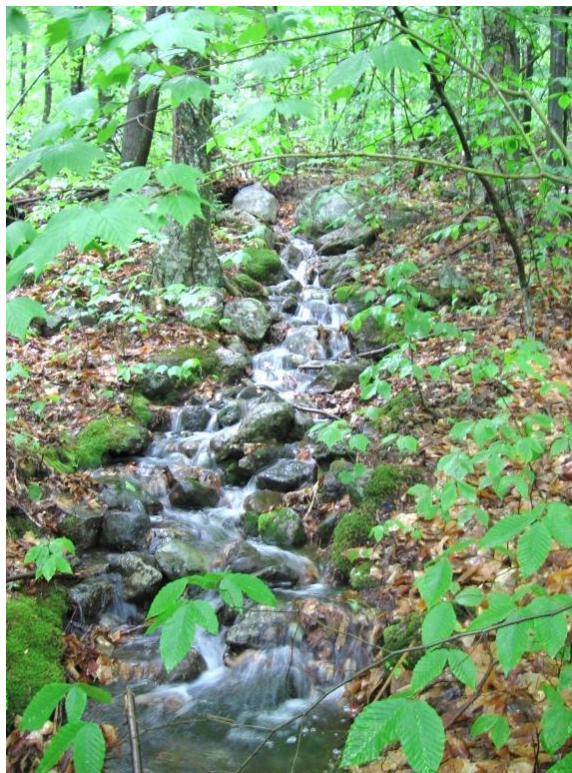
Criteria	Evidence
Channel	✓ Upstream segment (A) is on a hill side and has a step-pool channel that is common to steep streams. The downstream segment has a standard channel with rock substrate (B).
A. Mineral channel bed	✓ There is exposed mineral substrate caused by flowing water
B. Blue line on topographic map	✗ It is not shown as a blue line on the topographic map
C. Continuous flow for 6 months	✗ Dries up
D. Aquatic life	✓ Both segments A and B have a variety of macroinvertebrates.
E. Aquatic vegetation	✗ None
Conclusion	✓ Both segments A and B have a channel with defined banks and 2 of the 5 other criteria. Despite drying up in the summer, both segments would qualify as NRPA streams.

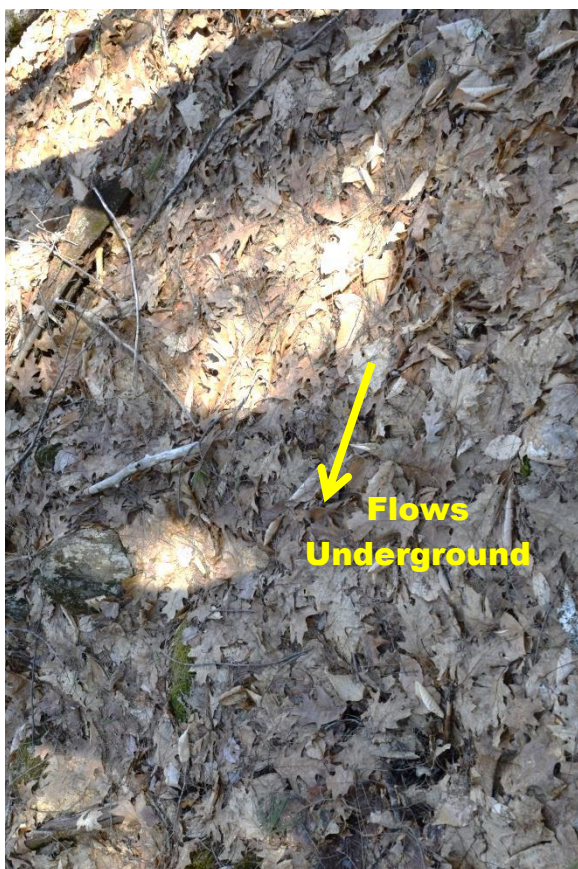
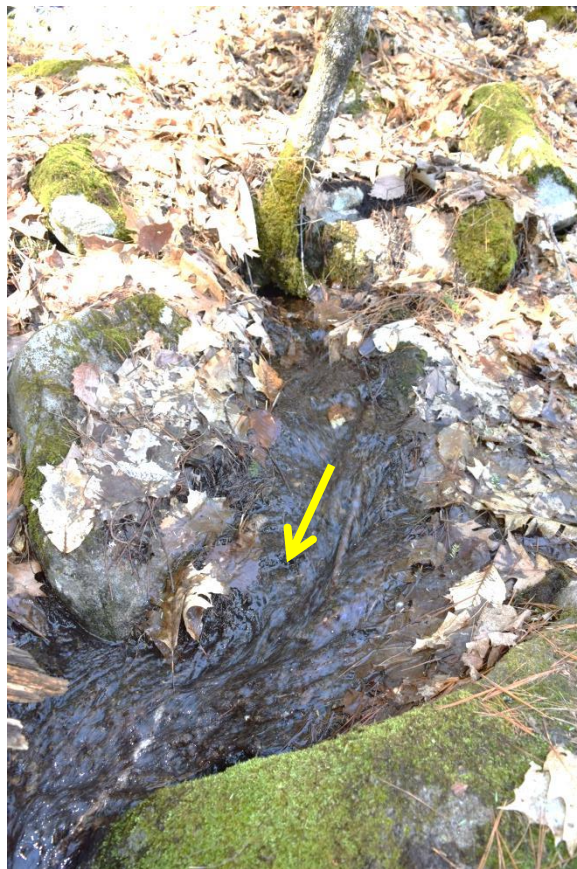
## Case Study 5 – Stream that goes above and below ground (2 pages)

Segment A – Flows underground

Criteria	Evidence
Channel	✗ There is a channel with defined banks upstream, but then the water goes underground in Segment A. One can hear the water flowing underground.
A. Mineral channel bed	✗ The underground segment does not have a channel with mineral bed
B. Blue line on topographic map	✗ No
C. Continuous flow for 6 months	✗ No
D. Aquatic life	?
E. Aquatic vegetation	✗ None
Conclusion	✗ Segment A does not have a defined channel

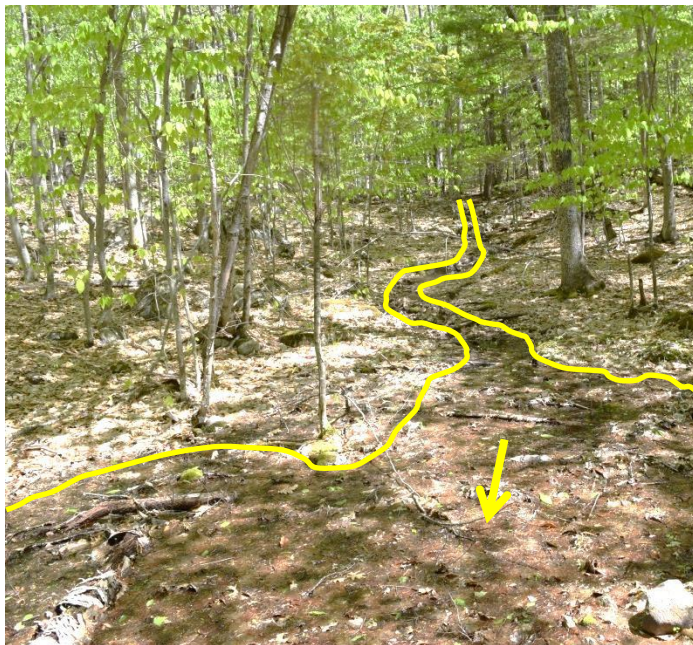
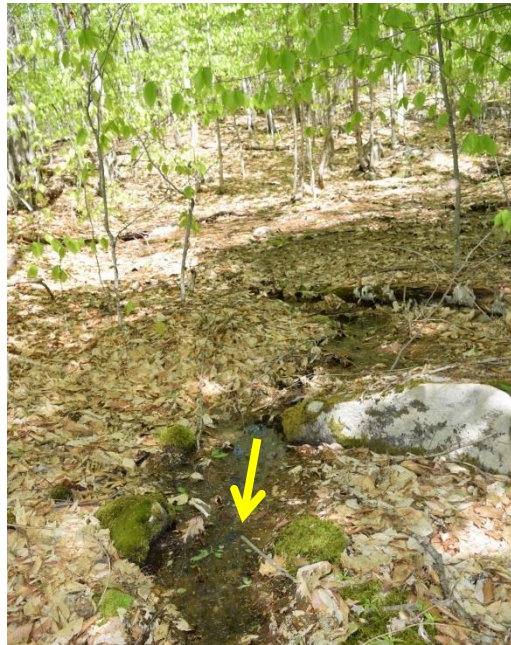
<b>Criteria</b>	<b>Evidence</b>
Channel	✓ Small channel with defined banks (3-8 inches wide)
A. Mineral channel bed	✓ Composed of sand, silt, and gravel
B. Blue line on topographic map	× It is not shown as a blue line on the topographic map
C. Continuous flow for 6 months	× Not evaluated, but most likely dries up most years
D. Aquatic life	✓ Several different kinds of aquatic macroinvertebrates, such as mayflies, stoneflies, caddisflies, and blackflies. A two-lined salamander was observed.
E. Aquatic vegetation	× None
Conclusion	✓ It has a defined channel and meets 2 of the 5 other criteria. This segment is a NRPA stream.

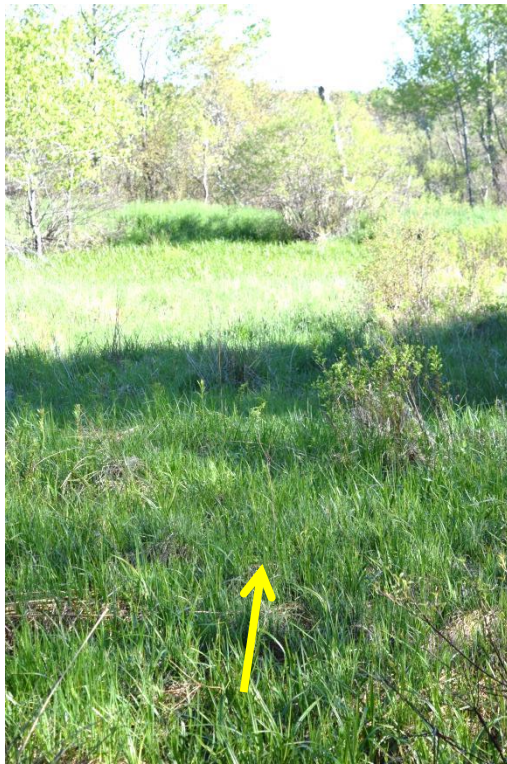
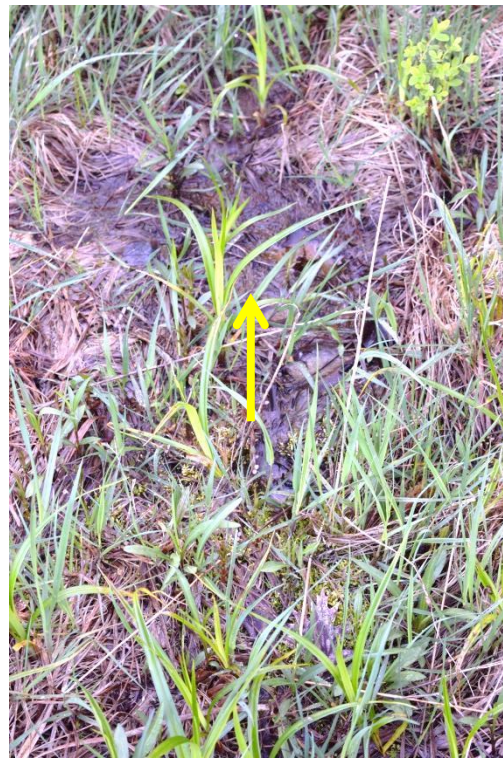
## Case Study 7 – A marsh without a channel

Criteria	Evidence	
Channel	×	Water flowing through plants when water levels are high, but no channel
A. Mineral channel bed	×	There is some exposed mud, but not a channel
B. Blue line on topographic map	×	It is not shown as a blue line on the topographic map
C. Continuous flow for 6 months	×	Dries up
D. Aquatic life	✓	Some macroinvertebrates
E. Aquatic vegetation	×	None
Conclusion	✗	This is not a NRPA stream. It does not have a defined channel and is a wetland. Wetlands are protected resources under NRPA.

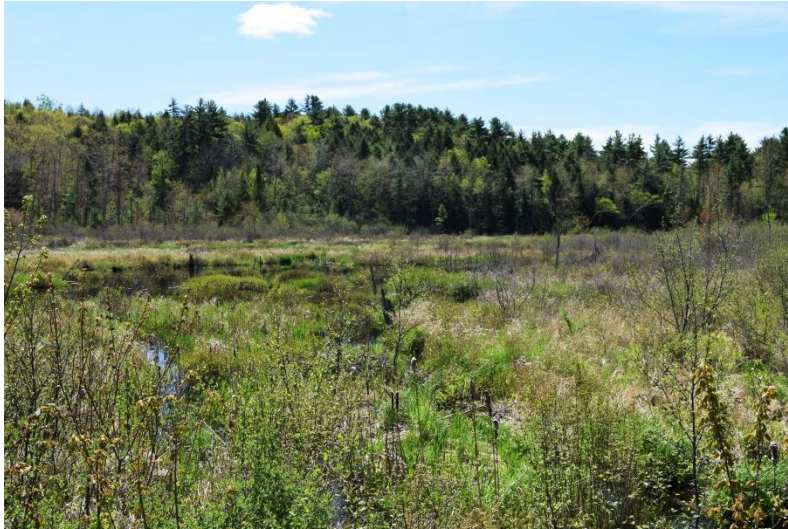
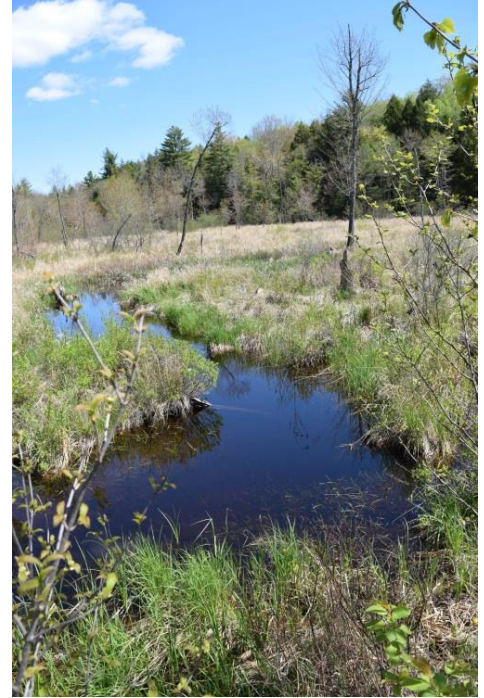
Criteria	Evidence
Channel	✓ Although there appears to be no channel from View 1, there is clearly a channel with defined banks if one explores a little (View 2).
A. Mineral channel bed	✓ Composed of silt, sand, and gravel
B. Blue line on topographic map	✓ Solid line
C. Continuous flow for 6 months	✓ The central channel never dries up.
D. Aquatic life	✓ Many different kinds of aquatic macroinvertebrates, such as mayflies, stoneflies, and caddisflies. Fish were observed.
E. Aquatic vegetation	✓ Several kinds of aquatic plants
Conclusion	✓ It has a defined channel and meets all other criteria. It is a NRPA stream.

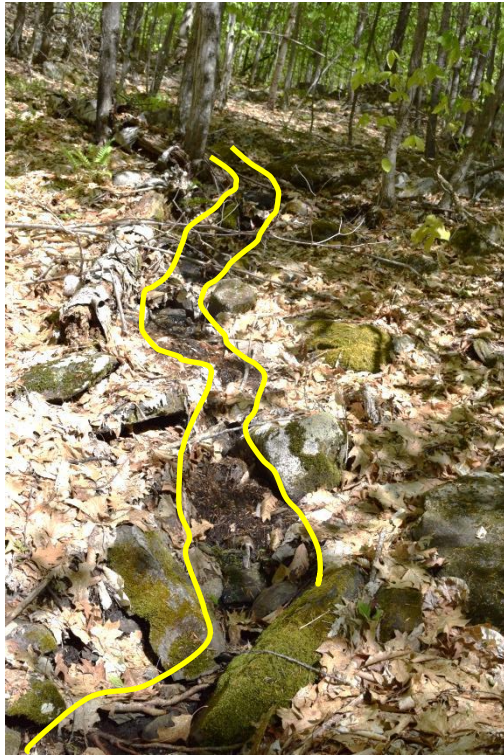
## Case Study 9 – Dry channel

Criteria	Evidence
Channel	✓ Channel with defined banks (yellow lines added to show banks)
A. Mineral channel bed	✓ Composed of silt, sand, and rocks
B. Blue line on topographic map	✗ It does not appear on a map
C. Continuous flow for 6 months	✗ Dries up
D. Aquatic life	✓ Caddisfly cases were found on a rock and a few macroinvertebrates were found in the last remaining pool
E. Aquatic vegetation	✗ None
Conclusion	✓ Despite being mostly dry, this is a NRPA stream because it has a channel and 2 of 5 criteria.

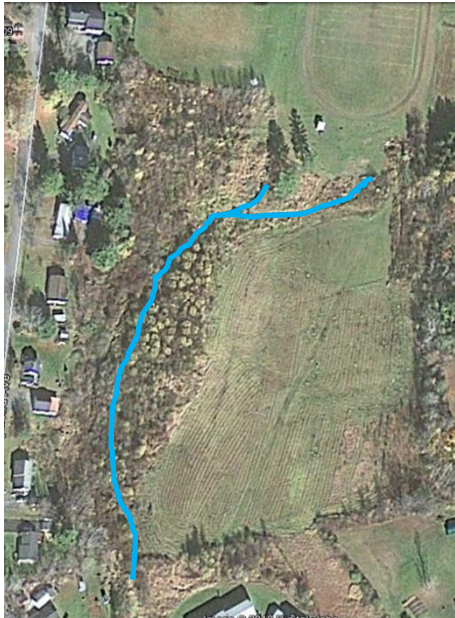
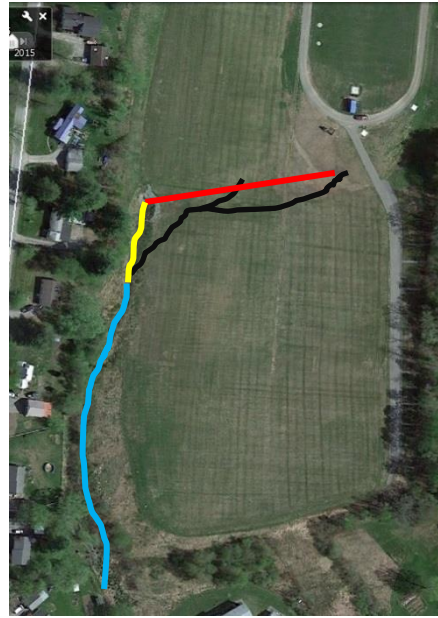
A stream (A & B – blue lines) was modified to accommodate the construction of an athletic field. The stream originated from 2 pipes before construction because of the original athletic fields. A section of stream was buried (B – black lines). A pipe was installed to convey water (B – red line). Part of the channel was relocated to minimize impacts of the project (B – yellow line).

Criteria	Evidence
Channel	✓ Channel with defined banks (A – blue lines) with a relocated segment after construction (B – yellow line)
A. Mineral channel bed	✓ Composed of cobble, gravel, and sand
B. Blue line on topographic map	✗ It is not shown as a blue line on the topographic map
C. Continuous flow for 06 months	-- Not assessed
D. Aquatic life	✓ Several kinds of macroinvertebrates observed
E. Aquatic vegetation	✗ None
Conclusion	✓ The entire stream is a NRPA stream, including the relocated segment that now originates from a culvert (B – yellow line). It has a channel and has 2 of 5 of the other criteria.

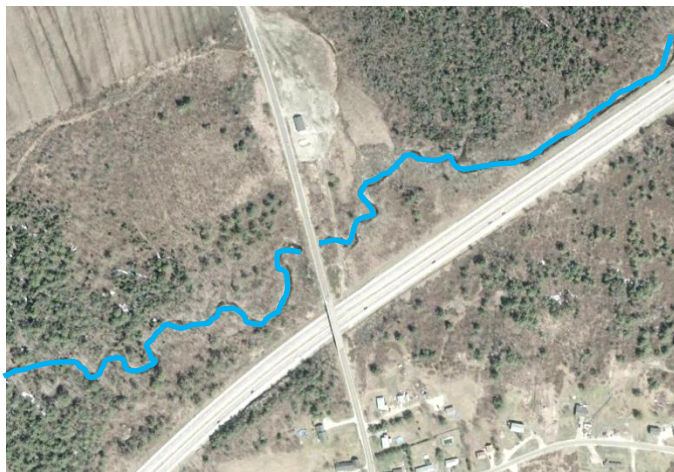
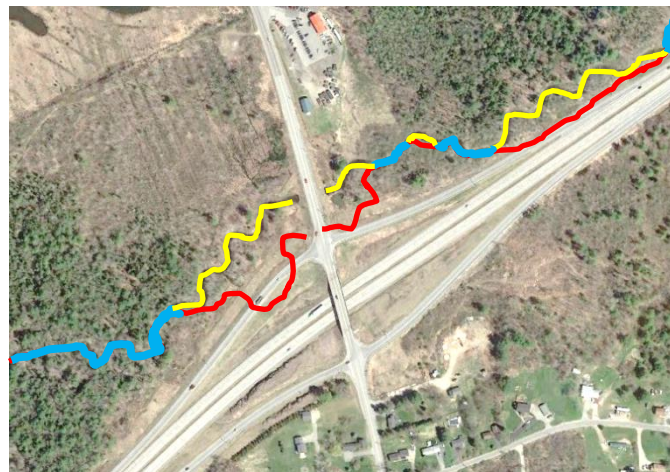
B – After construction of exit ramps

Parts of a stream were relocated to accommodate construction of highway ramps and to move a portion of the stream away from the highway. Blue lines show the stream channel prior to construction (A and B). Red lines show buried stream segments (B). Yellow lines show relocated stream segments (B).

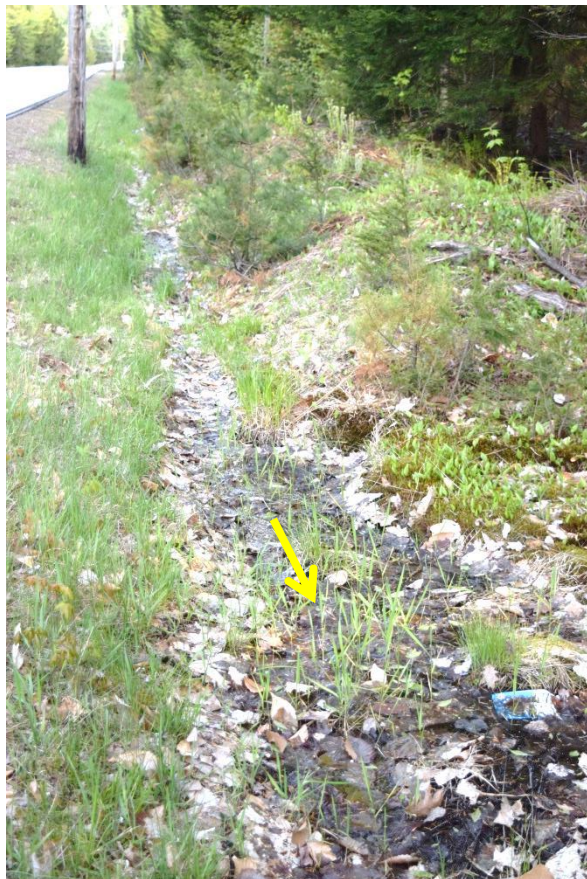
## Case Study 12 – Roadside Drainage #1

Criteria		Evidence
Channel	✓	Within the drainage feature, there is a narrow, meandering channel.
Ditch or Stream?	✗	Channel gradually decreases in size and disappears upstream. It is not connected to an upstream waterbody, such as a stream, spring, or wetland. It is periodically dredged by road crews.
A. Mineral channel bed	✓	Sand and silt
B. Blue line on topographic map	✗	It does not appear on a map
C. Continuous flow for 6 months	✗	It is periodically wet after snow melt and rain storms
D. Aquatic life	✓	There were a few aquatic macroinvertebrates
E. Aquatic vegetation	✗	None
Conclusion	✗	Despite having a channel and meeting 2 of the 5 other criteria, this is not a NRPA stream. The source of water is runoff from precipitation. It was constructed and is maintained to drain stormwater.

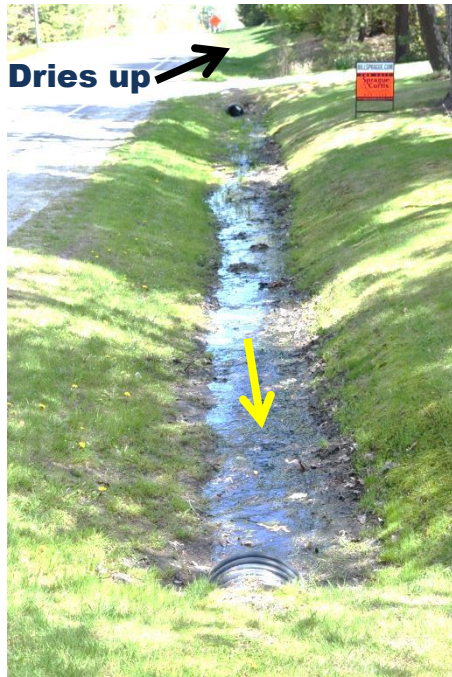
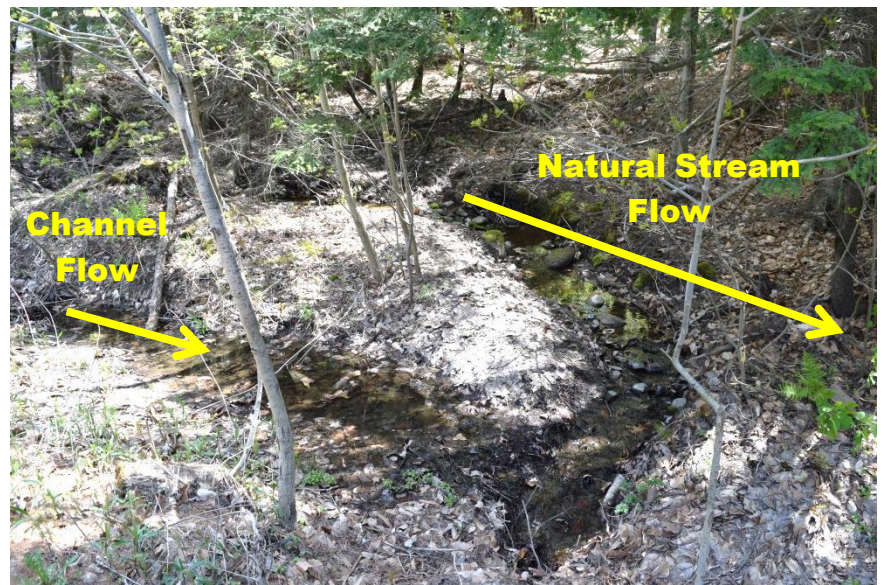
Criteria	Evidence
Channel	✓ Channel alongside of a road (A).
Ditch or Stream?	✗ The channel disappears further up the hill. It is not connected to a stream, spring, or wetland upstream. The primary source of water is stormwater runoff. The channel joins a natural stream channel downstream (B).

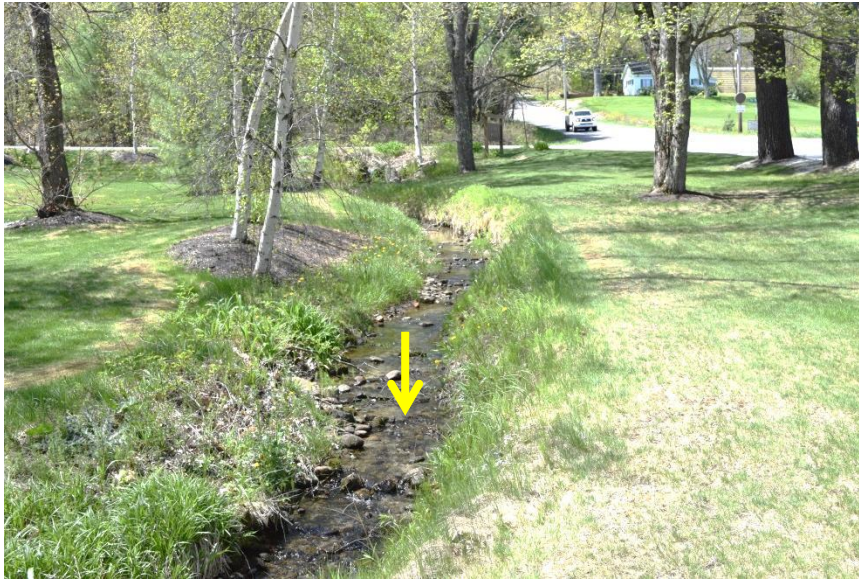
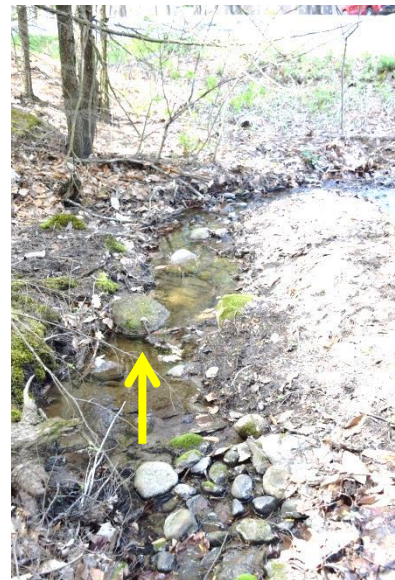
Criteria	Evidence
Channel	✓ Channel with defined banks (A, looking upstream).
Ditch or Stream?	✓ Upstream, the channel connects to a natural stream (B, looking downstream). Further downstream of where the picture A was taken, the channel goes under the road and then returns to a natural channel.
A. Mineral channel bed	✓ Composed of sand, gravel, and cobble
B. Blue line on topographic map	✗ It does not appear on a map
C. Continuous flow for 6 months	-- Not evaluated
D. Aquatic life	✓ Several kinds of aquatic macroinvertebrates
E. Aquatic vegetation	✗ None
Conclusion	✓ This is a modified segment of a NRPA stream. It has a channel and has 2 of 5 of the other criteria.

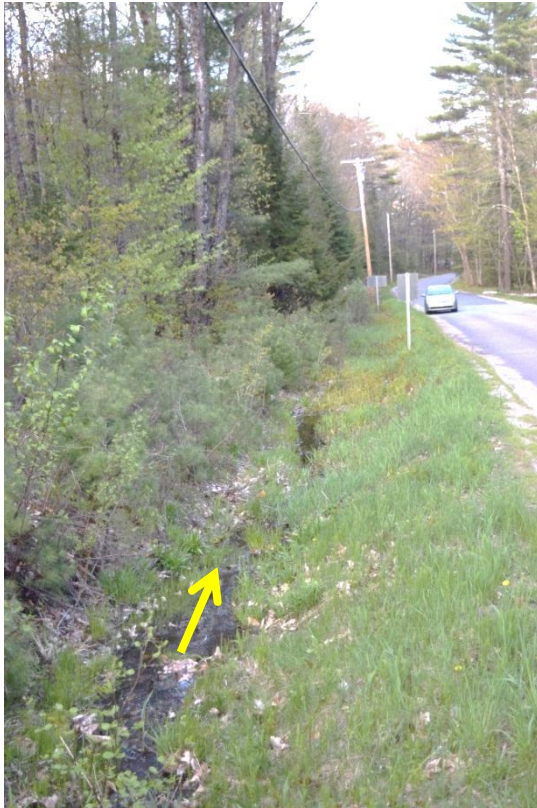
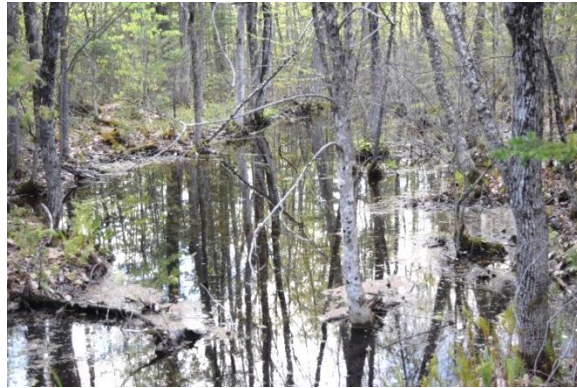
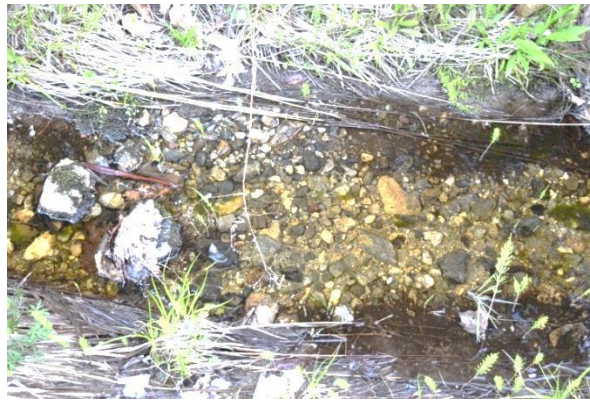
Criteria	Evidence
Channel	✓ Channel with defined banks alongside of road (A)
Ditch or stream?	✓ The channel originates from a small wetland (B), flows through the forest, and then flows parallel to the road in a modified channel. Further downstream, water flows under the road through culvert and proceeds as a natural stream. This is not a ditch created solely for stormwater. It is a relocated stream.

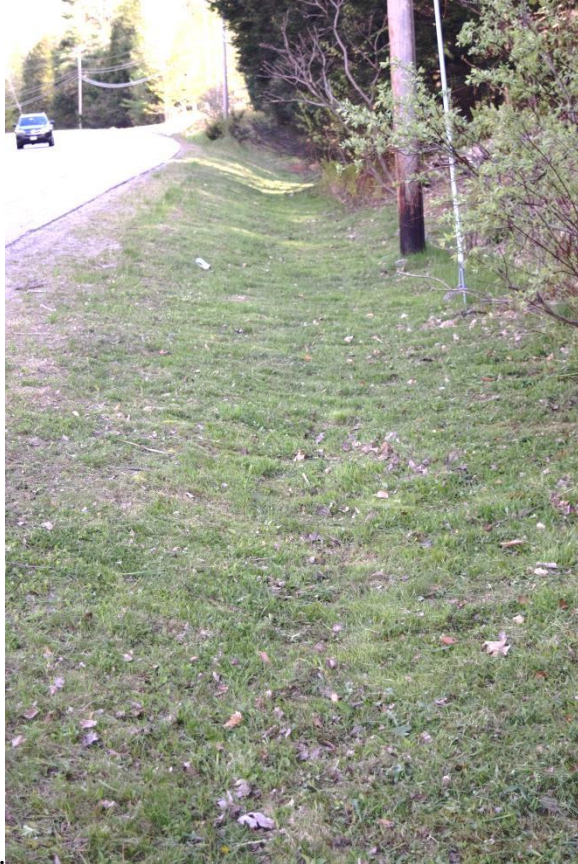
## Case Study 16 – Grassy Swale

Criteria	Evidence
Channel	✗ No channel with defined banks
A. Mineral channel bed	✗ No exposed minerals caused by flowing water
B. Blue line on topographic map	✗ It is not shown as a blue line on the topographic map
C. Continuous flow for 6 months	✗ Dry most of the year
D. Aquatic life	✗ None
E. Aquatic vegetation	✗ None
Conclusion	✗ This is not a NRPA stream because it does not have a defined channel. It also has none of the 5 characteristics of a NRPA stream.

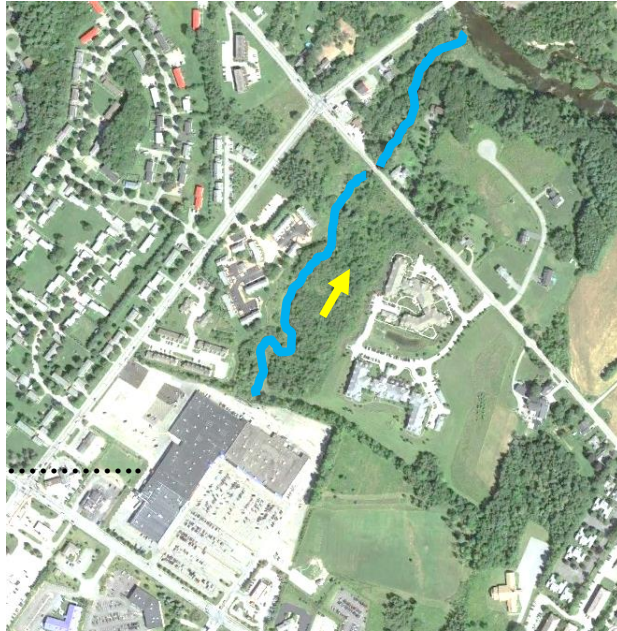
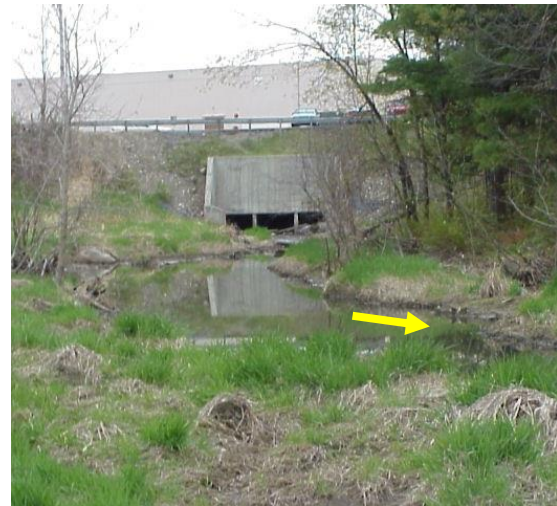
Criteria	Evidence	
Channel	✓	Channel with defined banks (A) that originates from a culvert (B)
A. Mineral channel bed	✓	Rocks
B. Blue line on topographic map	✓	Yes and historic topographic maps show that upstream segments have been buried or turned into ponds
C. Continuous flow for 6 months	✓	Yes
D. Aquatic life	✓	Fish and aquatic macroinvertebrates
E. Aquatic vegetation	×	No
Conclusion	✓	This is a NRPA stream. It has a channel with defined banks and 4 of 5 of the other criteria.

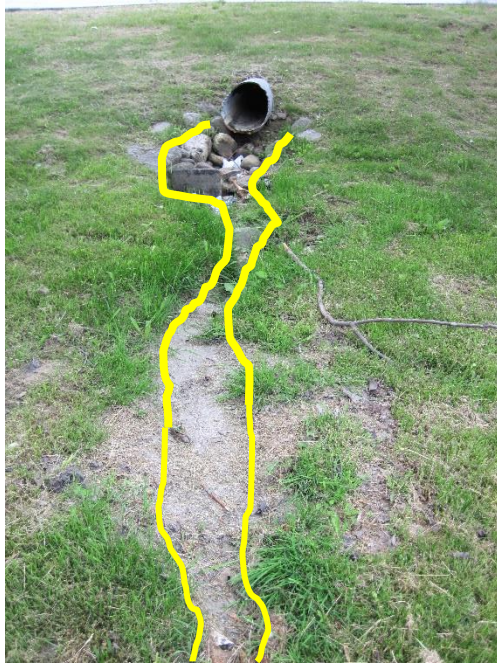
## Case Study 18 – Channel originating from a culvert #2

Criteria	Evidence
Channel	✓ Short channel with defined banks that originates from a culvert but dissipates into uplands
Ditch or stream	✗ This was created only to drain stormwater from a road network, it does not connect to an upstream waterbody, and it does not drain groundwater
A. Mineral channel bed	✓ Exposed minerals caused by flowing water
B. Blue line on topographic map	✗ It is not shown as a blue line on the topographic map
C. Continuous flow for 6 months	✗ Dry most of the year and does not have sustained flow from groundwater
D. Aquatic life	✗ None
E. Aquatic vegetation	✗ None
Conclusion	✗ This is not a NRPA stream because it was created solely for draining stormwater

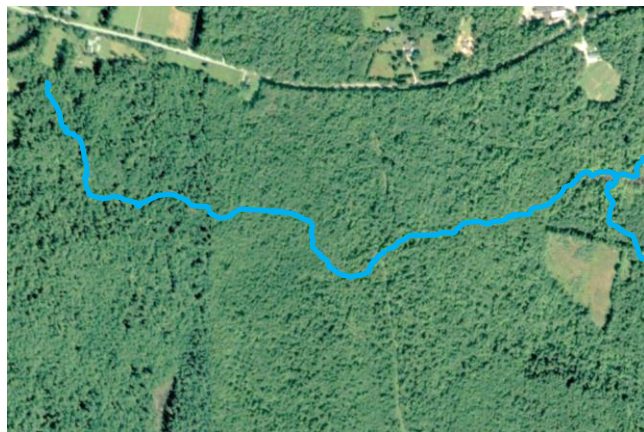
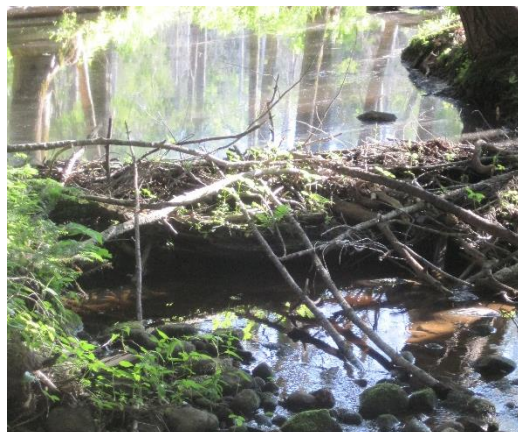
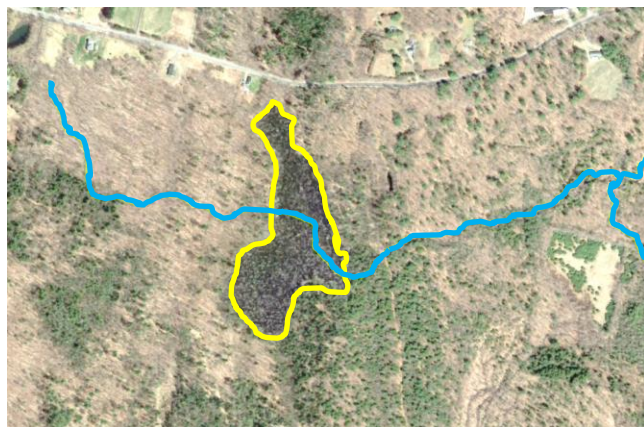
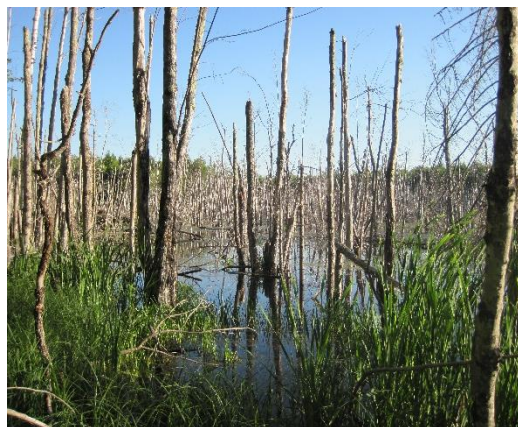
Blue lines show the stream channel and yellow line shows the outline of the beaver pond

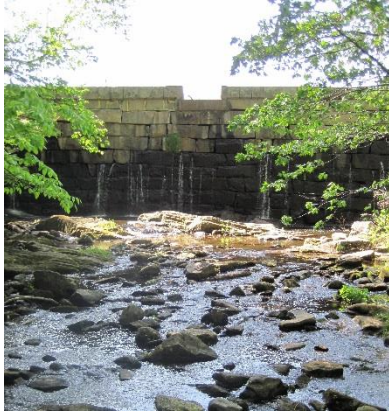
A – Dam

## Case Study 20 – Impounded stream #2

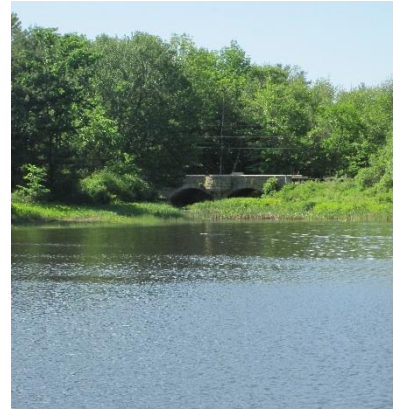
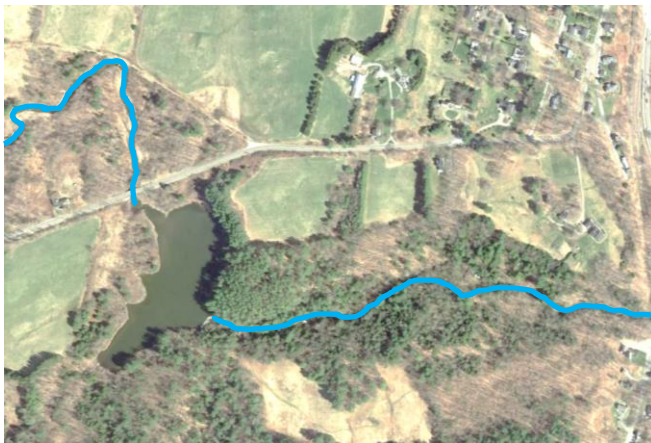
Criteria	Evidence	
Channel	✓	The inlet and outlet streams have channels with defined banks
A. Mineral channel bed	✓	Bedrock, boulders, and cobble
B. Blue line on topographic map	✓	Yes
C. Continuous flow for 6 months	✓	Yes
D. Aquatic life	✓	Aquatic macroinvertebrates and fish
E. Aquatic vegetation	×	None
Conclusion	✓	Construction of a dam flooded an existing stream channel. The new impoundment retains the protection afforded to the original stream channel under NRPA.

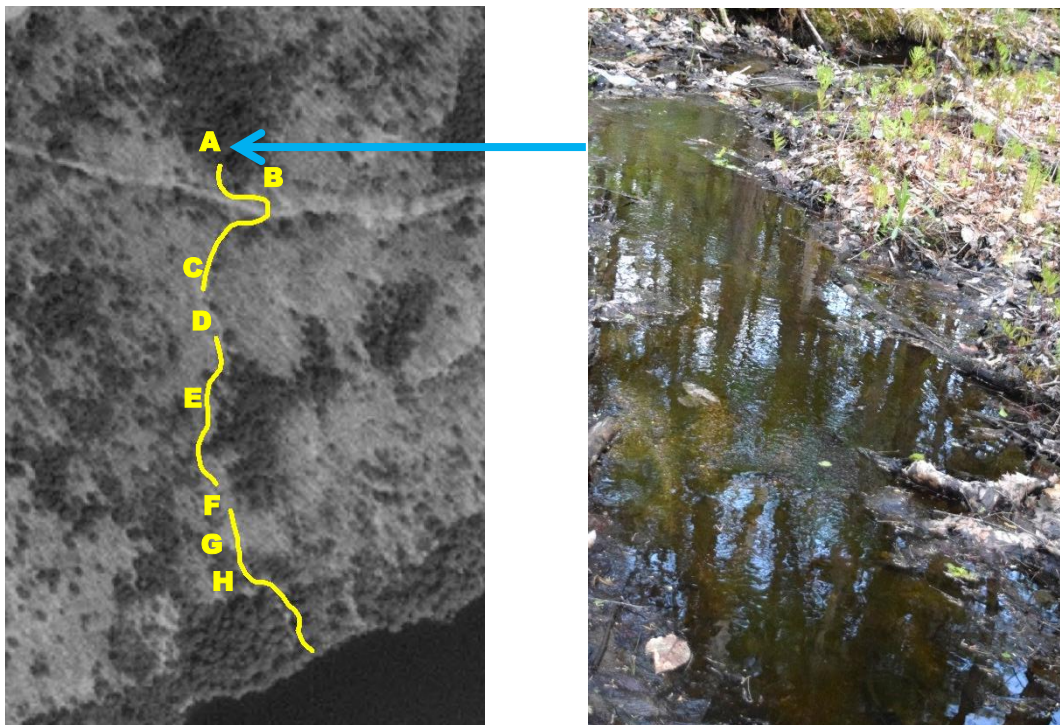
Criteria	Evidence	
Channel	×	No channel
A. Mineral channel bed	×	No channel
B. Blue line on topographic map	×	It is not shown as a blue line on the topographic map
C. Continuous flow for 6 months	×	Dries up
D. Aquatic life	✓	Some macroinvertebrates
E. Aquatic vegetation	✓	Some aquatic plants and mosses
Conclusion	✗	This is a wetland or vernal pool. It does not have a defined channel. Wetlands and vernal pools are protected resources under NRPA.

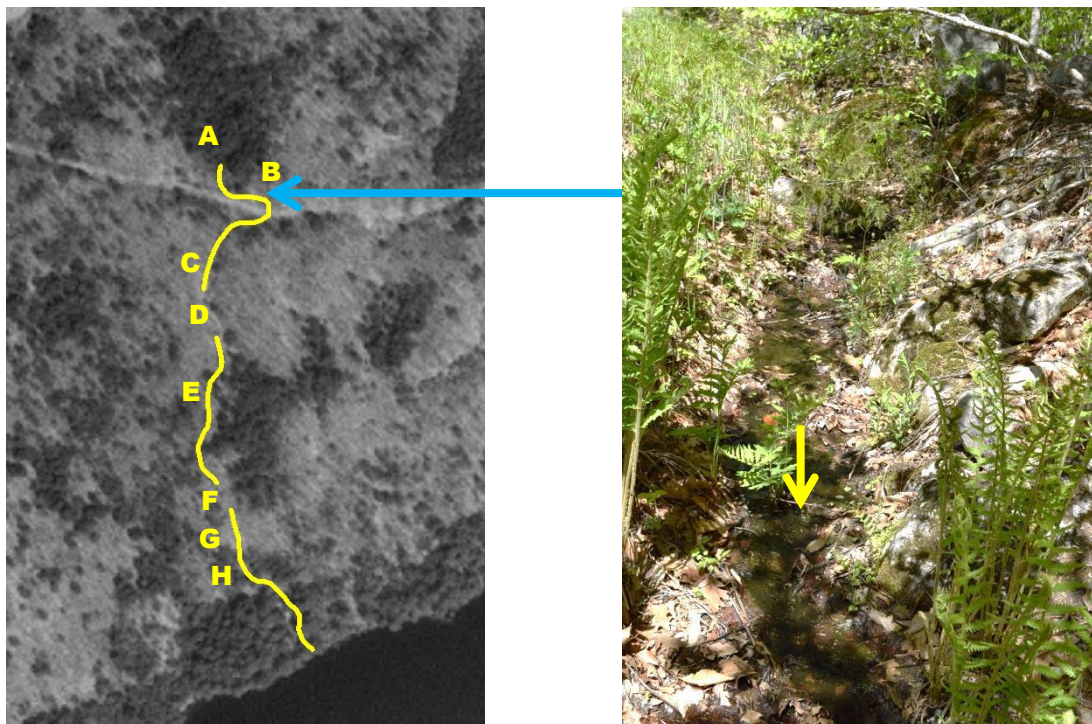
Criteria	Evidence
Channel	✓ Within a roadside drainage, there is a narrow meandering channel (3-5" wide)
Ditch or Stream?	✓ The channel originates from a wetland, flows a short distance as a natural channel, and then is captured by a roadside drainage
