# Natural Resource Protection Act (NRPA) Identification Guide for Rivers, Streams, and Brooks

Babel Brook, Ebeemee TWP

MAINE DEPARTMENT OF ENVIRONMENTAL PROTECTION  
17 State House Station | Augusta, Maine 04333-0017  
<http://www.maine.gov/dep/>

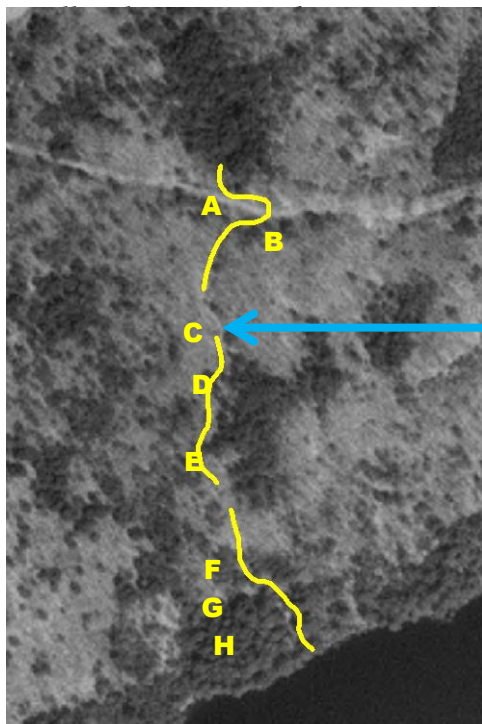
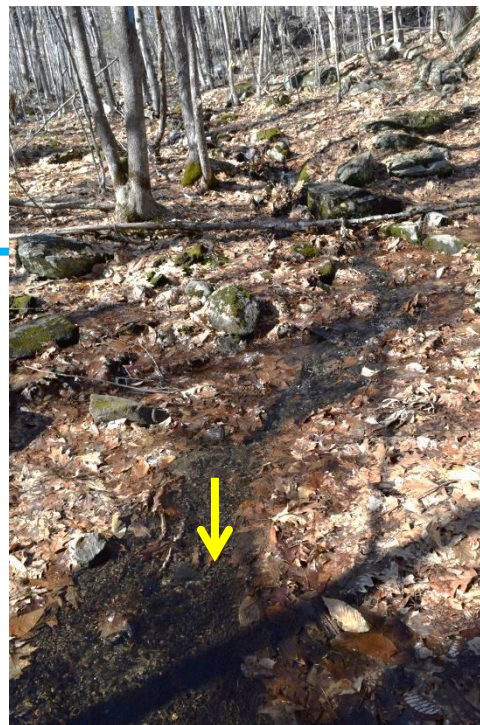
Criteria	Evidence	
Channel	✓	Channel with defined banks
A. Mineral channel bed	✓	Composed of sand and gravel
B. Blue line on topographic map	×	It is not shown as a blue line on the topographic map
C. Continuous flow for 6 months	×	No
D. Aquatic life	✓	Several different kinds of aquatic macroinvertebrates
E. Aquatic vegetation	×	None
Conclusion	✓	This is a NRPA stream because it has a defined channel and has 2 of 5 characteristics of a NRPA stream.

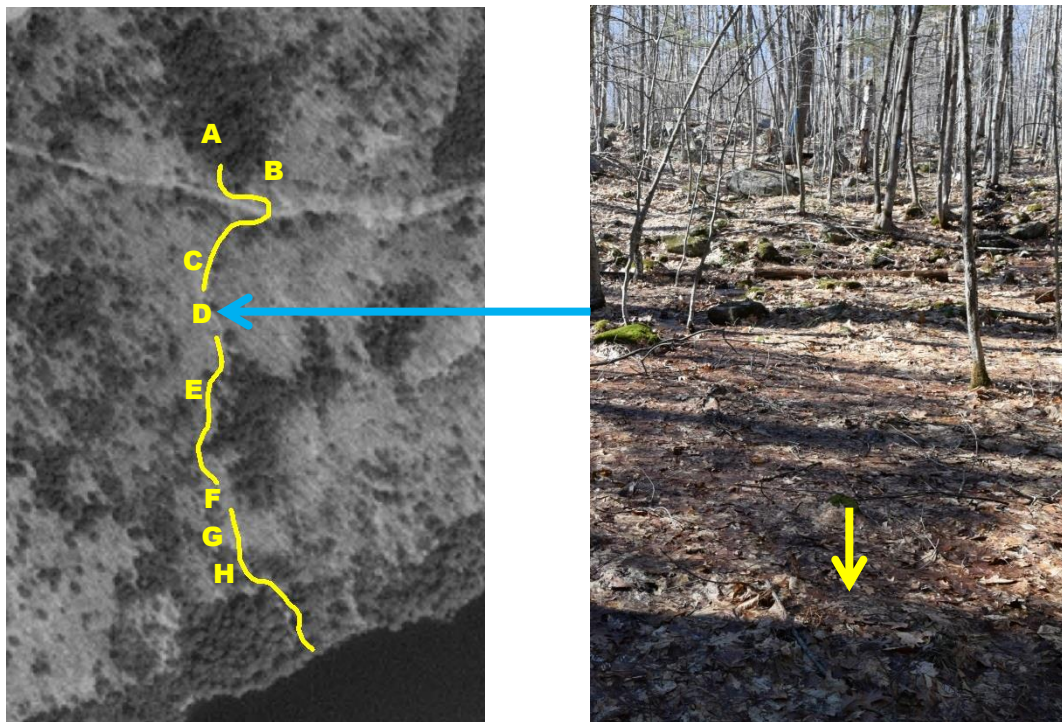
Criteria	Evidence	
Channel	×	The stream enters a flat area, the water spreads out, and there no longer is a channel with defined banks
A. Mineral channel bed	×	There is no exposed mineral substrate caused by water movement
B. Blue line on topographic map	×	It is not shown as a blue line on the topographic map
C. Continuous flow for 6 months	×	Dries up
D. Aquatic life	✓	Some macroinvertebrates
E. Aquatic vegetation	×	None
Conclusion	✗	This segment is not a NRPA stream because it does not have a channel with defined banks

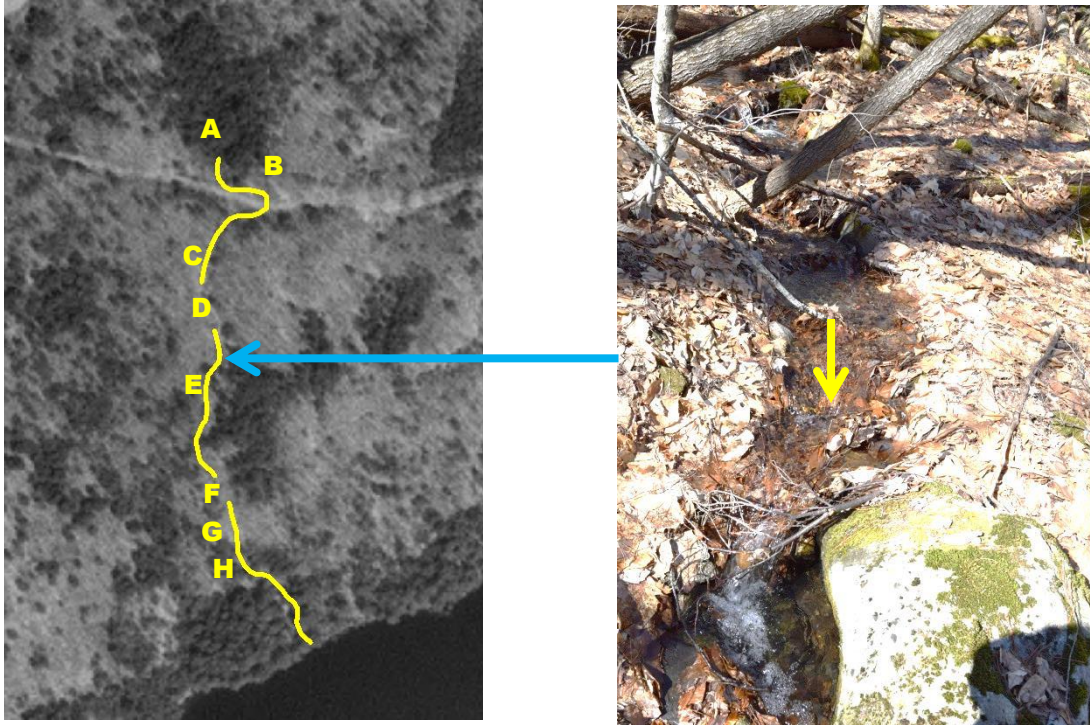
E. NRPA stream segment

Criteria	Evidence
Channel	✓ Channel with defined banks
A. Mineral channel bed	✓ Composed of sand and gravel
B. Blue line on topographic map	✗ It is not shown as a blue line on the topographic map
C. Continuous flow for 6 months	✗ No
D. Aquatic life	✓ Several different kinds of aquatic macroinvertebrates
E. Aquatic vegetation	✗ None
Conclusion	✓ This is a NRPA stream because it has a defined channel and 2 of 5 characteristics of a NRPA stream.

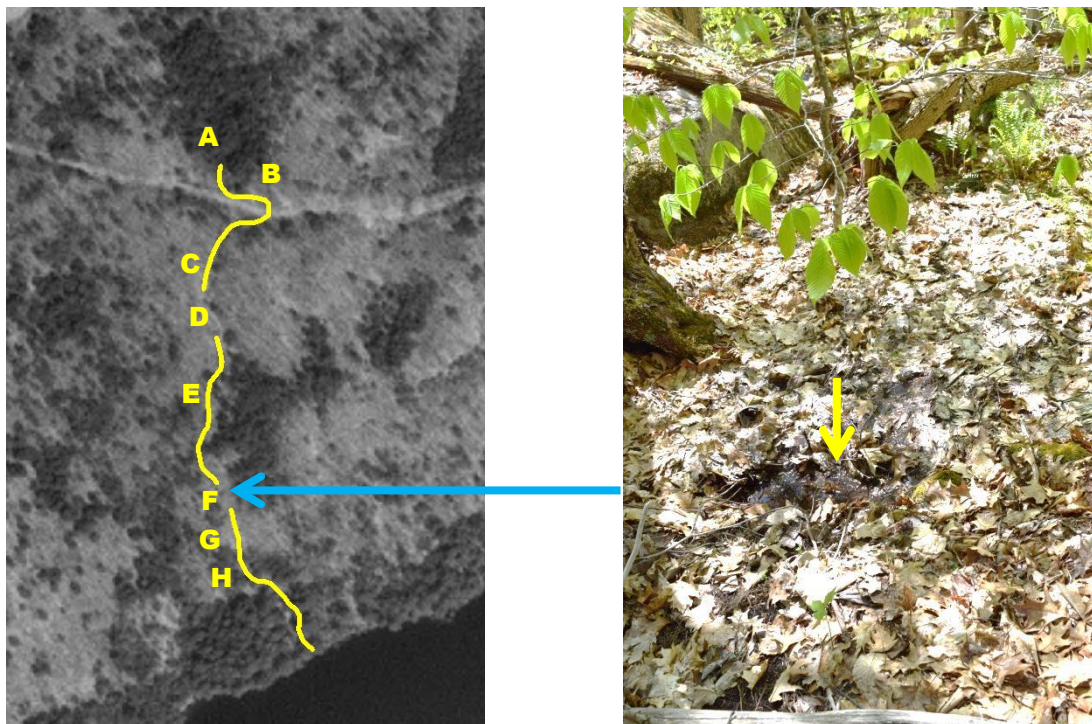
Criteria	Evidence
Channel	✗ The water flows underground in this segment
A. Mineral channel bed	✗ This segment does not have an exposed channel with mineral bed
B. Blue line on topographic map	✗ No
C. Continuous flow for 6 months	✗ No
D. Aquatic life	?
E. Aquatic vegetation	✗ None
Conclusion	✗ The underground segment does not have a defined channel

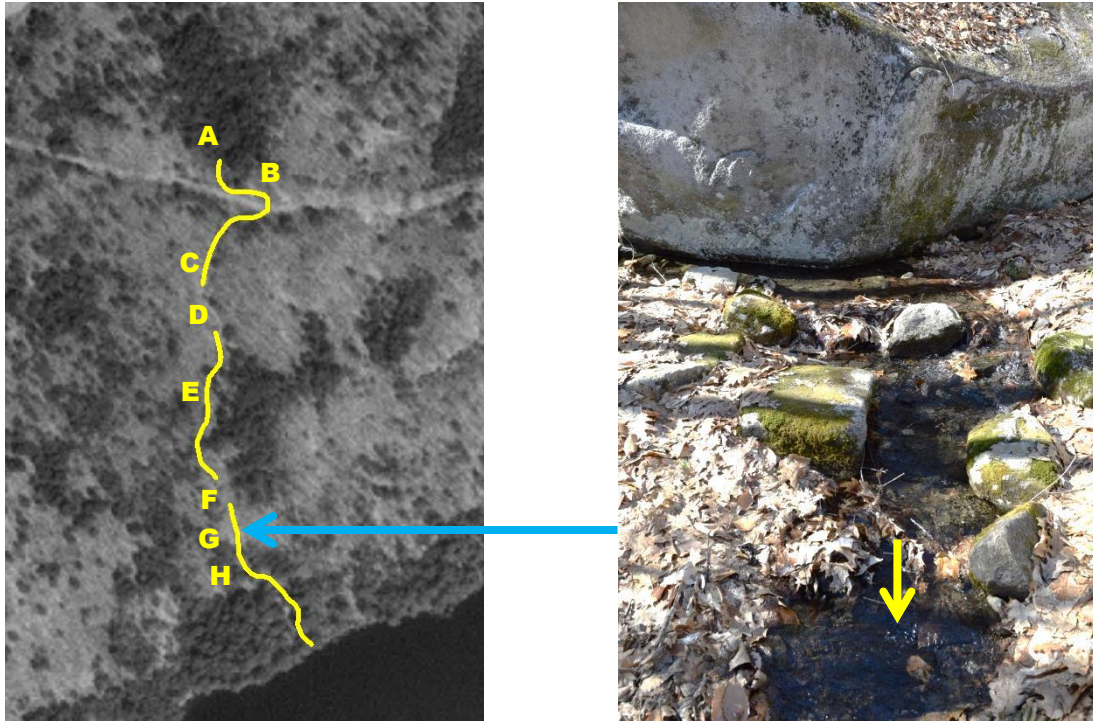
Criteria	Evidence
Channel	✓ The water returns to the surface next to the boulder and forms a channel with defined banks
A. Mineral channel bed	✓ Composed of sand and gravel
B. Blue line on topographic map	✗ It is not show as a blue line on the topographic map
C. Continuous flow for 6 months	✗ No
D. Aquatic life	✓ Several different kinds of aquatic macroinvertebrates
E. Aquatic vegetation	✗ None
Conclusion	✓ This is a NRPA stream because it has a defined channel and has 2 of 5 characteristics of a NRPA stream.

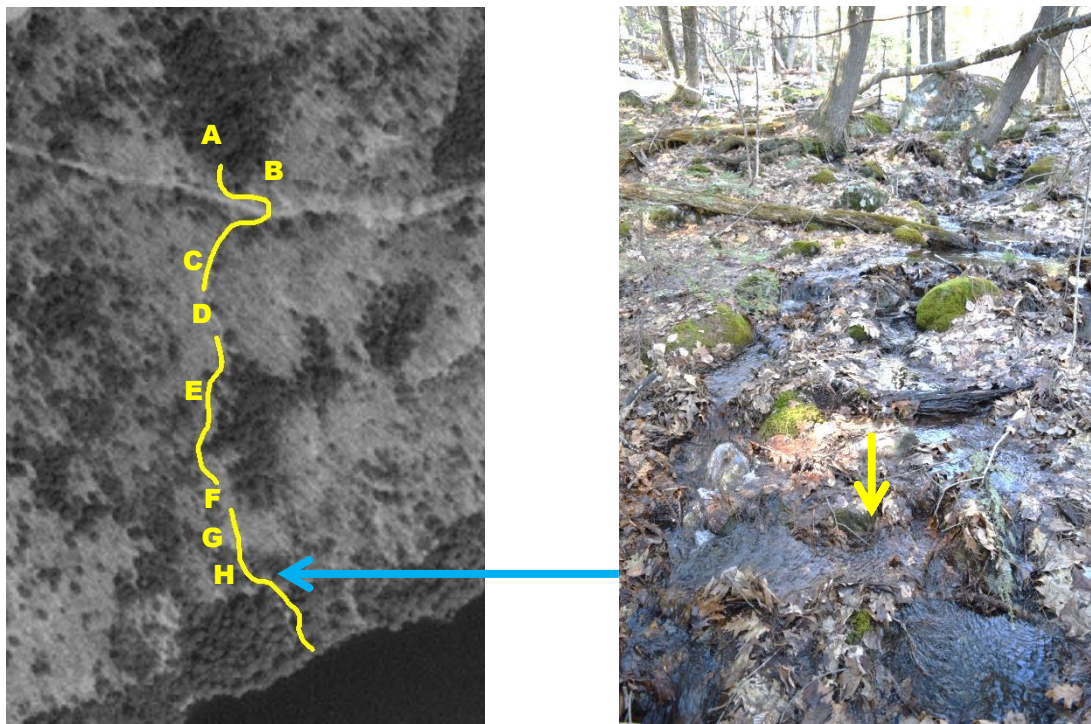
Criteria	Evidence	
Channel	✓	This channel is braided because of large rocks and steeper slope
A. Mineral channel bed	✓	Yes
B. Blue line on topographic map	×	It is not shown as a blue line on the topographic map
C. Continuous flow for 6 months	×	No
D. Aquatic life	✓	Several different kinds of aquatic macroinvertebrates
E. Aquatic vegetation	×	None
Conclusion	✓	This is a NRPA stream because it has a defined channel and has 2 of 5 characteristics of a NRPA stream.

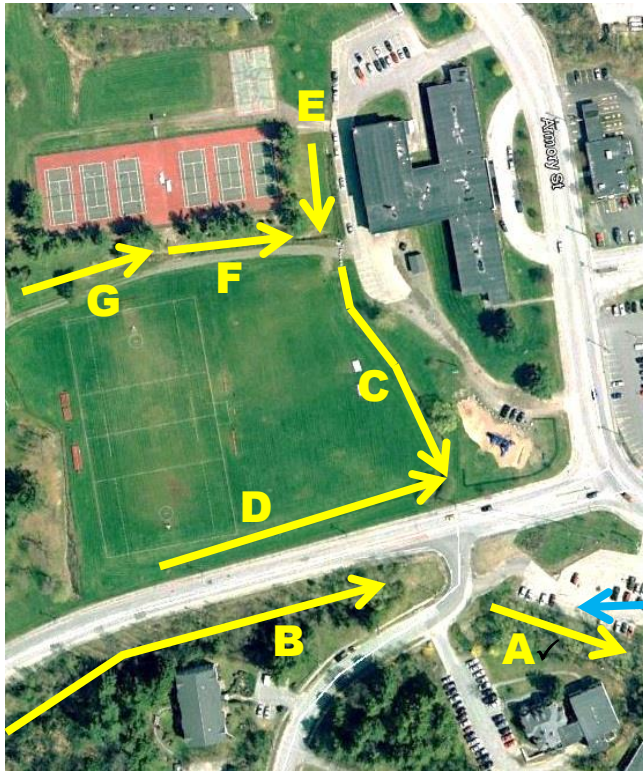
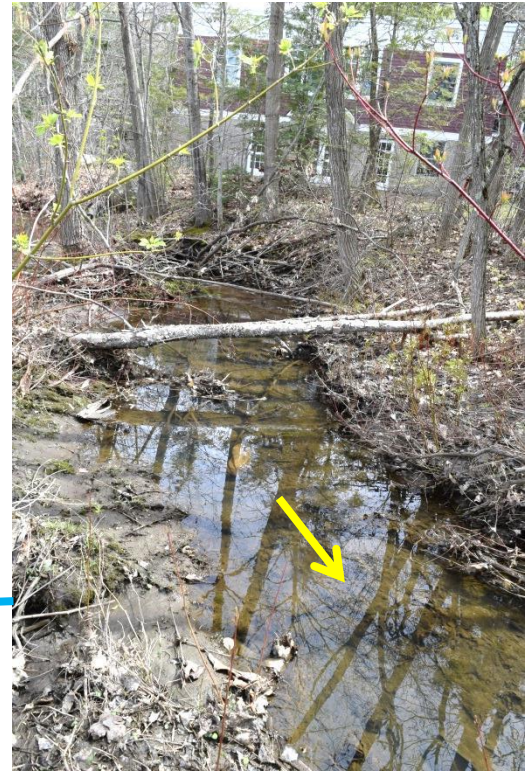
## Segment A: Perennial Stream

Criteria	Evidence	
Channel	✓	Channel with defined banks
A. Mineral channel bed	✓	Composed of rocks and sand
B. Blue line on topographic map	×	Does not appear on a map
C. Continuous flow for 6 months	✓	Continuous flow in most years
D. Aquatic life	✓	Many different kinds of aquatic macroinvertebrates
E. Aquatic vegetation	×	None
Conclusion	✓	This is Kennedy Brook. It has a defined channel and meets 3 of the 5 other criteria. It is a NRPA stream.

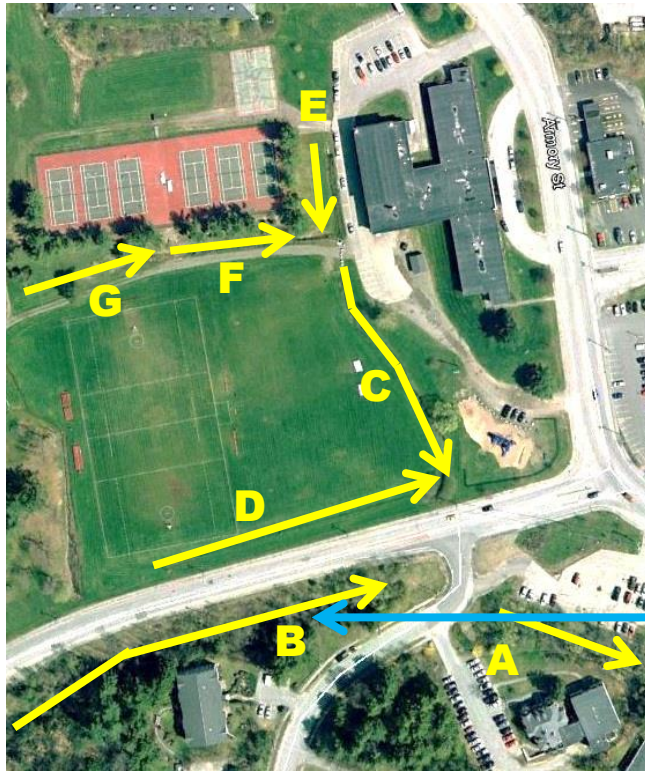
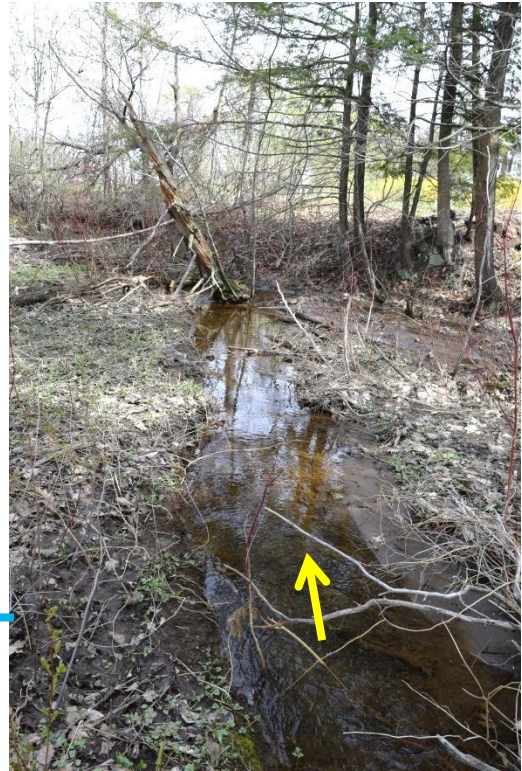
## Segment B: Perennial Stream

Channel	✓	Channel with defined banks
A. Mineral channel bed	✓	Composed of rocks and sand
B. Blue line on topographic map	×	Does not appear on a current map
C. Continuous flow for 6 months	✓	Continuous flow in most years
D. Aquatic life	✓	Many different kinds of aquatic macroinvertebrates
E. Aquatic vegetation	×	None
Conclusion	✓	This is Kennedy Brook. It has a defined channel and meets 3 of the 5 other criteria. It is a NRPA stream.

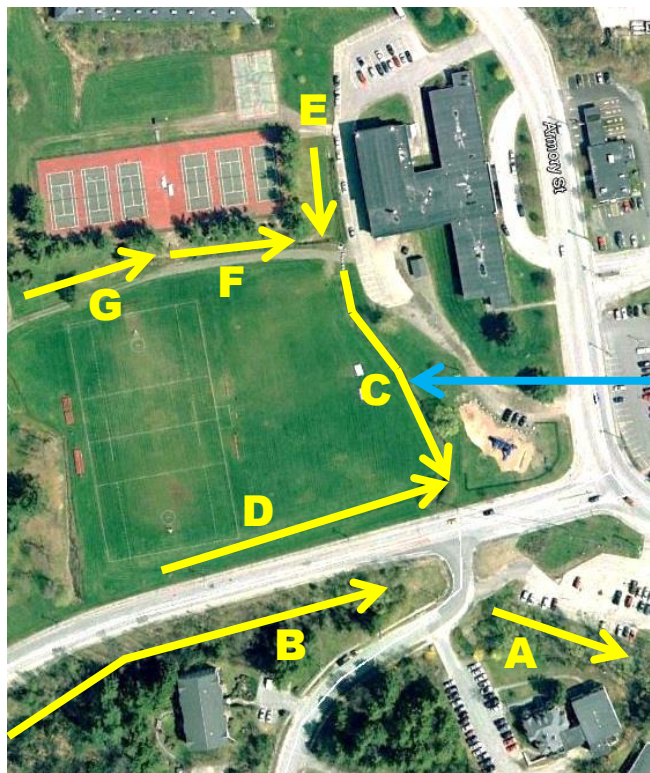
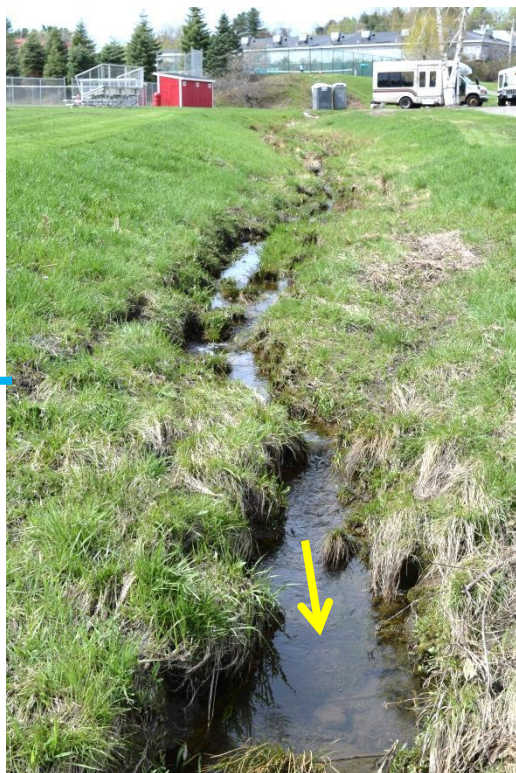
## Segment C: Modified stream segment

Criteria	Evidence	
Channel	✓	Channel with defined banks (some stream bank erosion and slumping)
A. Mineral channel bed	✓	Composed of rocks and sand
B. Blue line on topographic map	×	Does not appear on a current map, but a stream is shown in the vicinity on historic maps
C. Continuous flow for 6 months	✓	The channel has continuous water flow in most years
D. Aquatic life	✓	Several kinds of aquatic macroinvertebrates
E. Aquatic vegetation	×	None
Conclusion	✓	This is an altered branch of Kennedy Brook. It has a defined channel and meets 3 of the 5 other criteria. It is a NRPA stream. Its riparian zone is greatly altered.

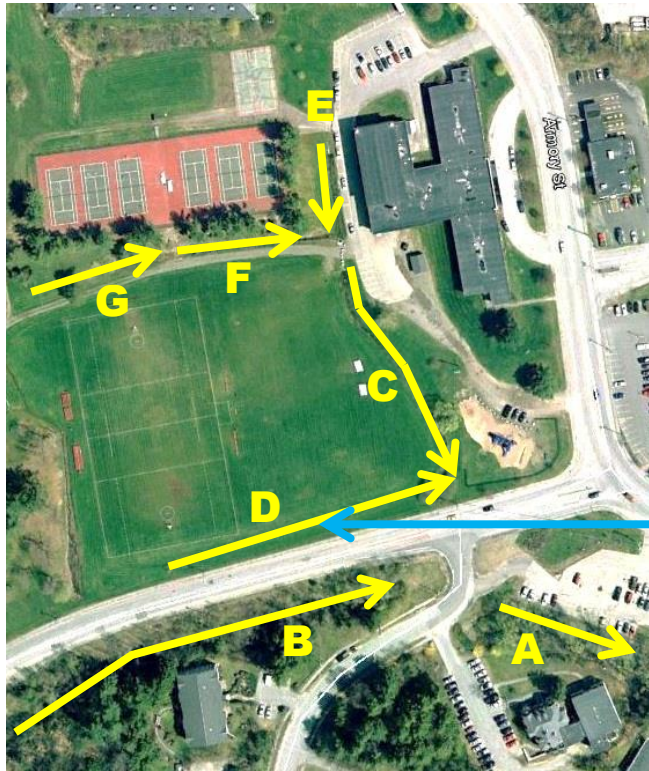
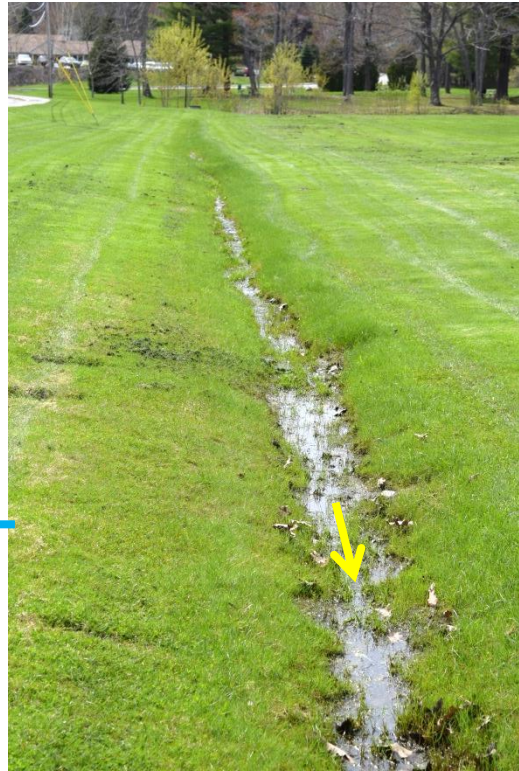
## Segment D: Grassy swale

Criteria	Evidence
Channel	× No channel with defined banks
A. Mineral channel bed	× No channel
B. Blue line on topographic map	× It does not shown as a blue line on the topographic map
C. Continuous flow for 6 months	× Dry most of the year
D. Aquatic life	× None
E. Aquatic vegetation	× None
Conclusion	× This is not a NRPA stream because it does not have a defined channel. It also has none of the 5 characteristics of a NRPA stream.

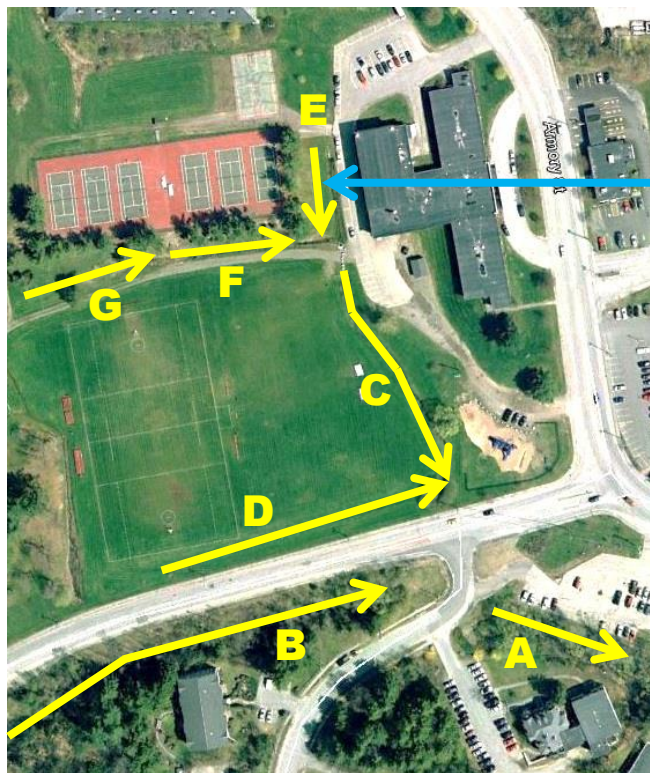
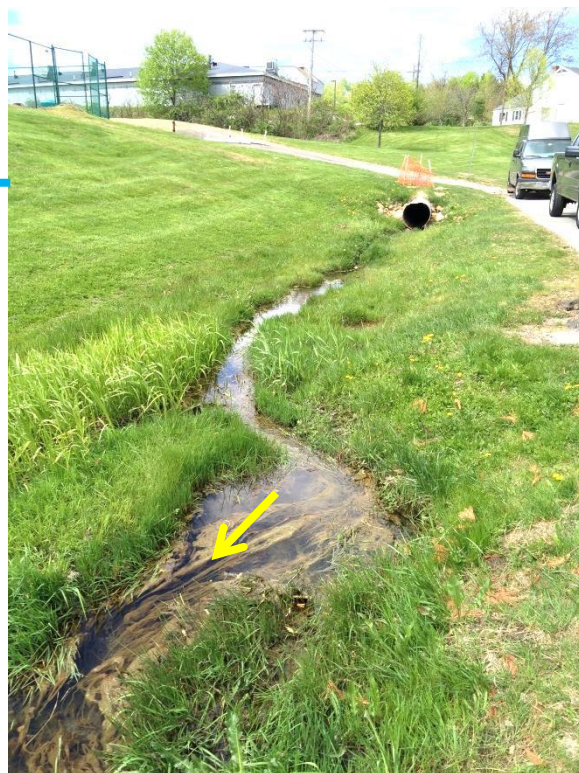
## Segment E: Modified stream segment that originates form a pipe

Criteria	Evidence
Channel	✓ It has a channel with defined banks, it has enough flowing water to maintain a channel away from the culvert opening, and it connects to a downstream waterbody
Ditch or Stream?	✓ The channel originates from a pipe, has continuous flow in most years, and is not only draining stormwater
A. Mineral channel bed	✓ Composed of sand and gravel
B. Blue line on topographic map	✗ It is not shown as a blue line on the current topographic map, but historic topographic maps show the presence of a stream nearby
C. Continuous flow for 6 months	✓ The channel has continuous water flow in most years
D. Aquatic life	✓ Several different kinds of aquatic macroinvertebrates
E. Aquatic vegetation	✗ None
Conclusion	✓ This is an altered headwater of Kennedy Brook, it has a defined channel, meets 3 of the 5 other criteria, and is a NRPA stream

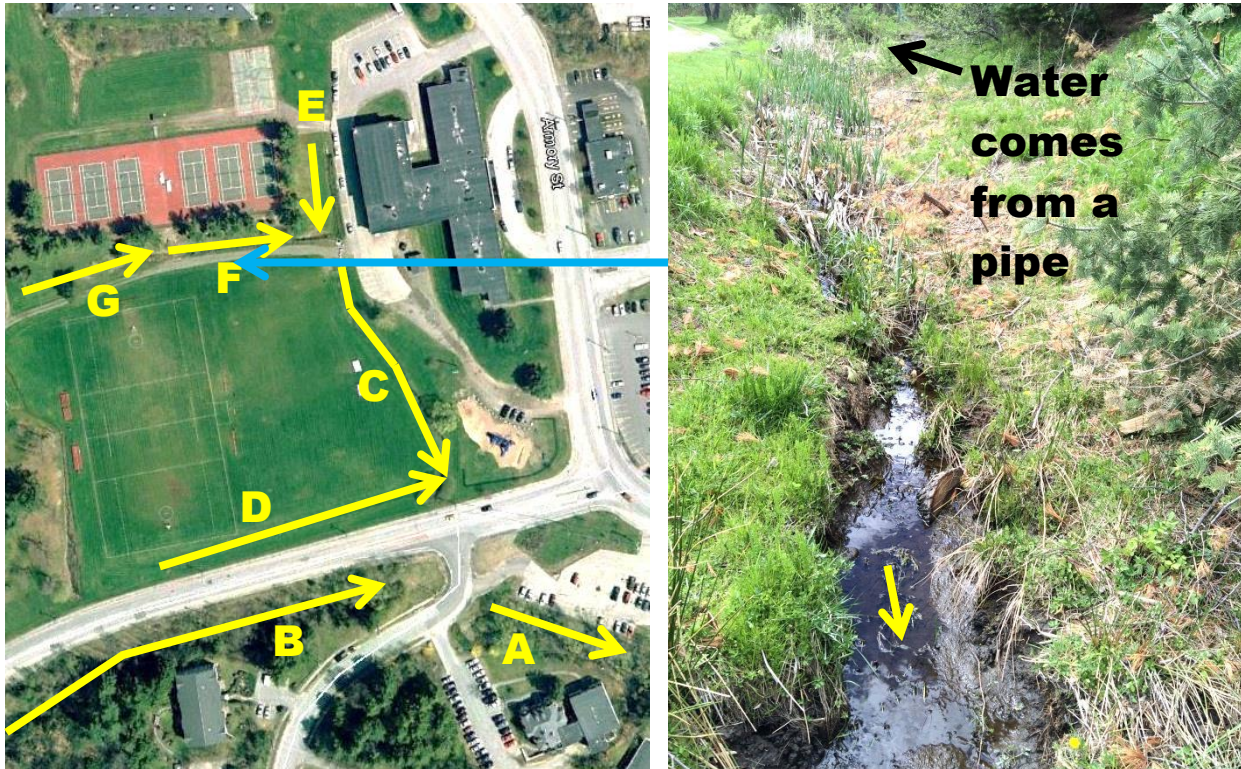
## Segment F: Modified stream segment that originates form a pipe

Criteria	Evidence
Channel	✓ There is a straight drainage way containing a channel with defined banks. Flowing water originates from a pipe that drains groundwater from underneath the tennis courts. There is enough flowing water to maintain a channel away from the culvert opening and it connects to Kennedy Brook.
Ditch or Stream?	✓ Stream. The source of water is groundwater. The altered channel has naturalized and is forming meanders.

C. Continuous flow for 6 months	-- Not sure but it remains wet for a long period of time and receives a lot of groundwater from the pipe that drains underneath the tennis courts. Groundwater sometimes comes to the surface of the tennis courts through cracks in the playing surface.

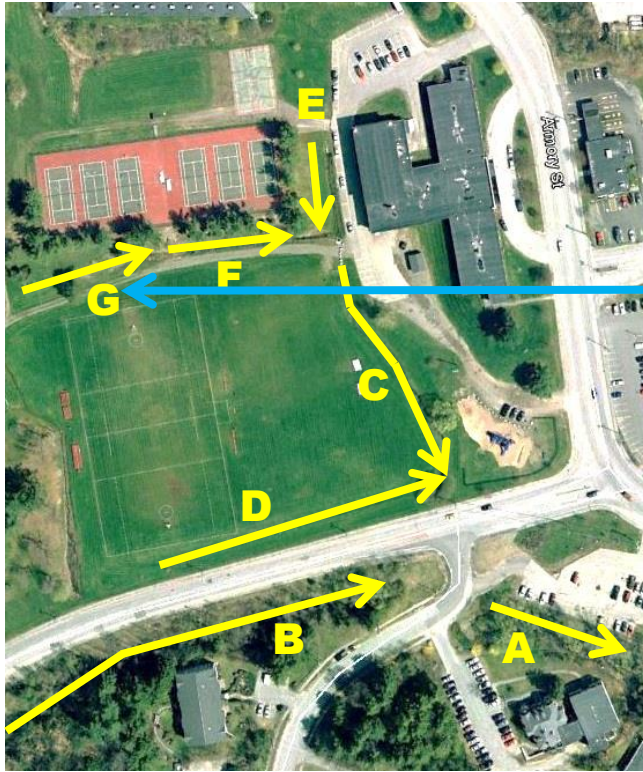
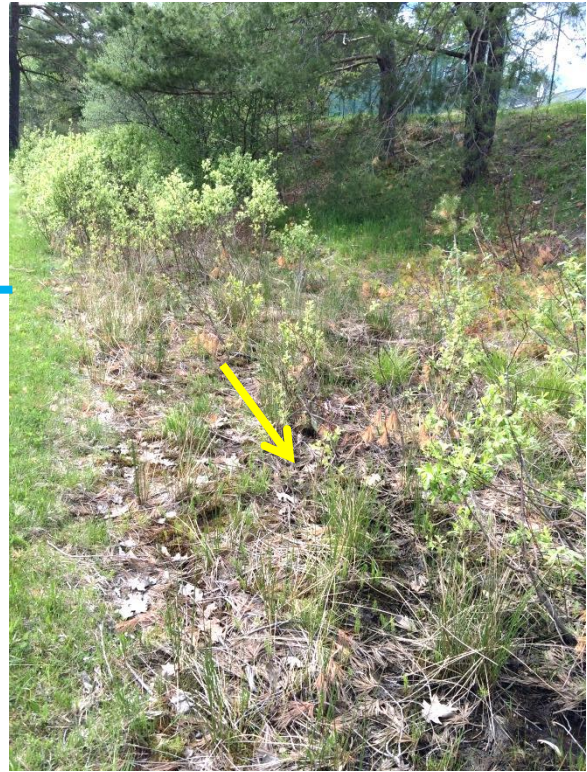
## Segment G: Linear wetland

Criteria	Evidence
Channel	✗ This is a straight drainage feature, but it does not have a channel with banks.
A. Mineral channel bed	✗ There is no exposed mineral substrate caused by water movement
B. Blue line on topographic map	✗ It is not shown as a blue line on the topographic map
C. Continuous flow for 6 months	✗ This segment dries up
D. Aquatic life	✗ None
E. Aquatic vegetation	✗ None
Conclusion	✗ This segment does not have a defined channel. It is functioning more like a linear wetland
